**Subject:** FCM Inspection Reports – Bridge No. 03024

**To:** Oklahoma City Public Works  
**From:** Jay Hyland, P.E.  
**Date:** 03/31/2015  
**Subject:** Off-System Routine/Fracture Critical Bridge Inspection  
NBI 03024, Structure 14N3160E1170001, N3160/Local ID: O-127

NBI #: 03024  
Structure #: 14N3160E1170001  
County: Cleveland

Facility Carried: N3160  
Feature Intersected: Creek  
Date: January 18, 2015

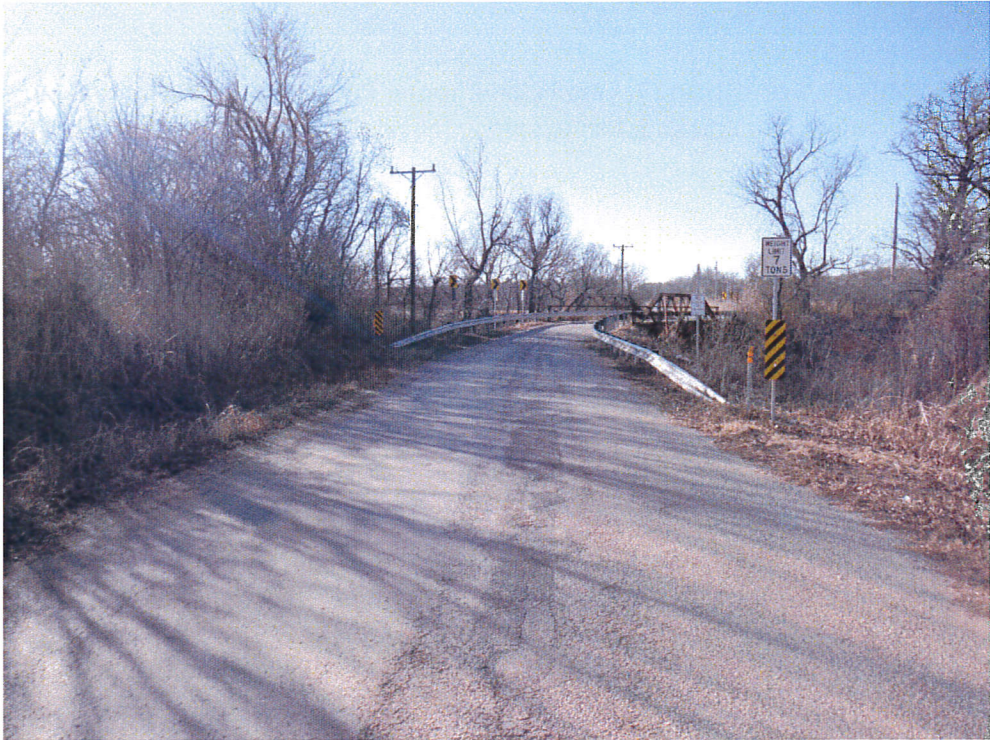
Figure 1: Bridge from North Approach

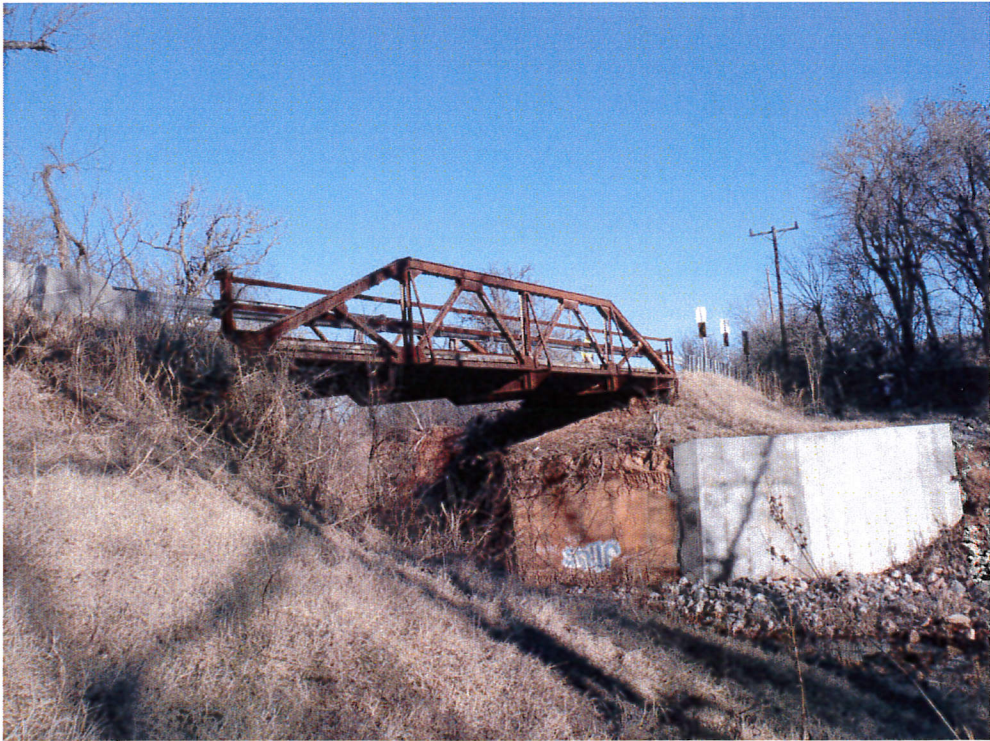
Figure 2: East Elevation

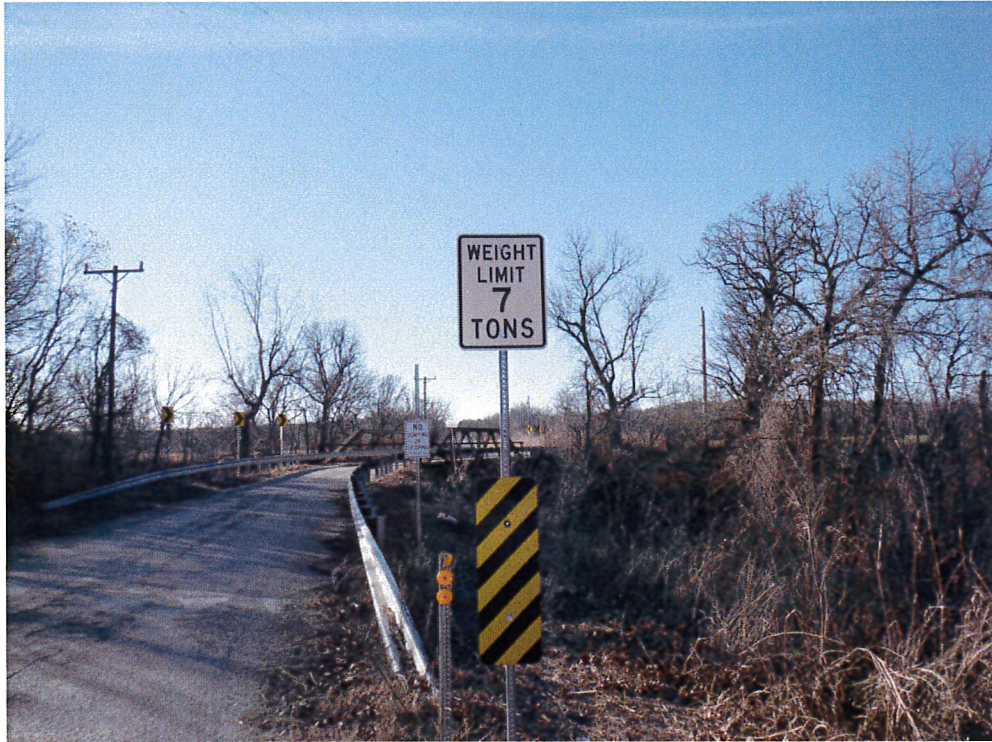
Figure 3: North Posting Sign

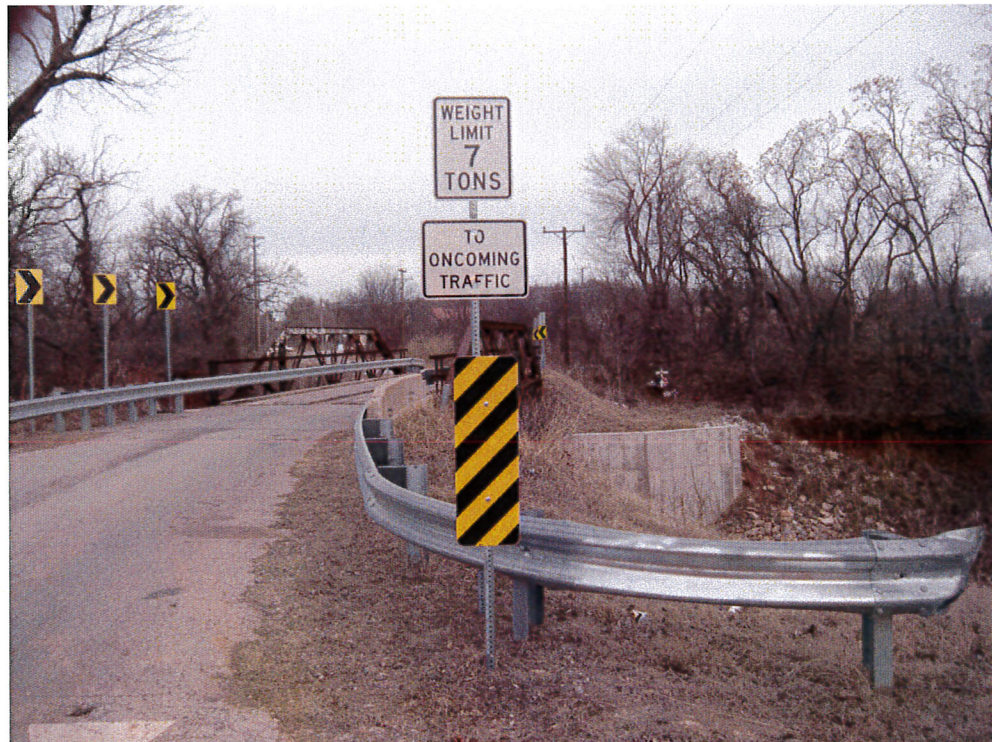
**NBI Item 36** – Traffic Safety – W-Beam Guard Rail in place across full length of bridge and past ends. Ends of guard turned down and buried. The Bridge end markers are in place. The North posting sign is in place but the South end it is missing at time of inspection. The Owner was notified and a new sign was installed.

Figure 4: South Posting Sign

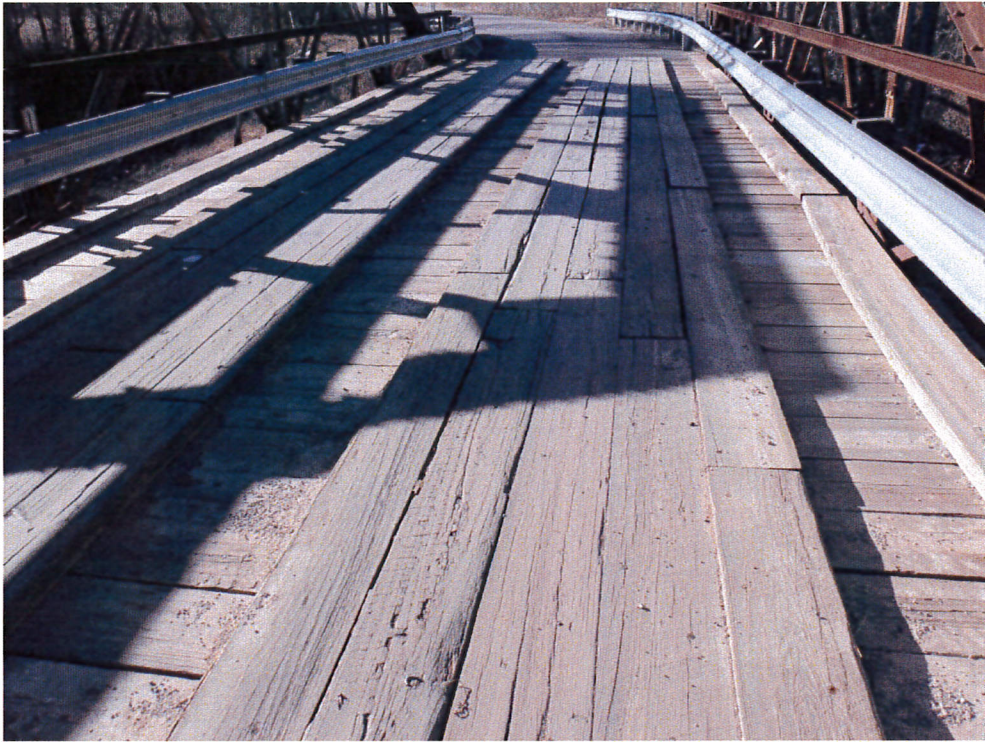
**NBI Item 58** – Deck (6, Satisfactory Condition) – The deck has minor to moderate wear to the wood runners with some minor cracking. The transverse planks have minor cracking at random locations. Some of the edge runners are warped and bowed with random cracks. All wood members are sound with no evidence of decay.

**Figure 5: Typical Cracking in Runners**

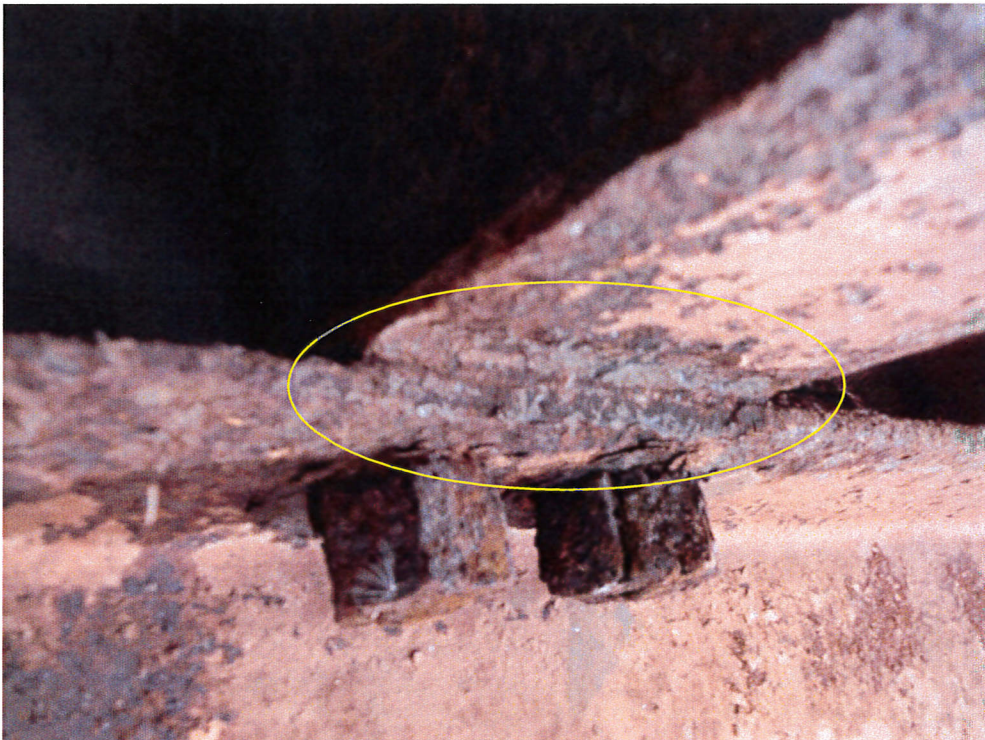
**Stringers** (5, Fair Condition) – All the stringers have minor freckled surface rust and some pitting up to 1/16” throughout. Stringers 4 & 5 ends at the N. Pier Cap (Abutment) have 10% and 30% section loss to the bottom flange respectively where they set on top of the abutment beam. Stringer 4 has minor section loss to bottom flange at FB5, Stringers 2, 6 & 8 have 30% to 10% section loss to bottom flange at FB4 and Stringers 2, 3 & 7 has up to 10% section loss to bottom flange at FB2.

**Figure 6: Section Loss to Bottom Flange of S5 at North Pier Cap**

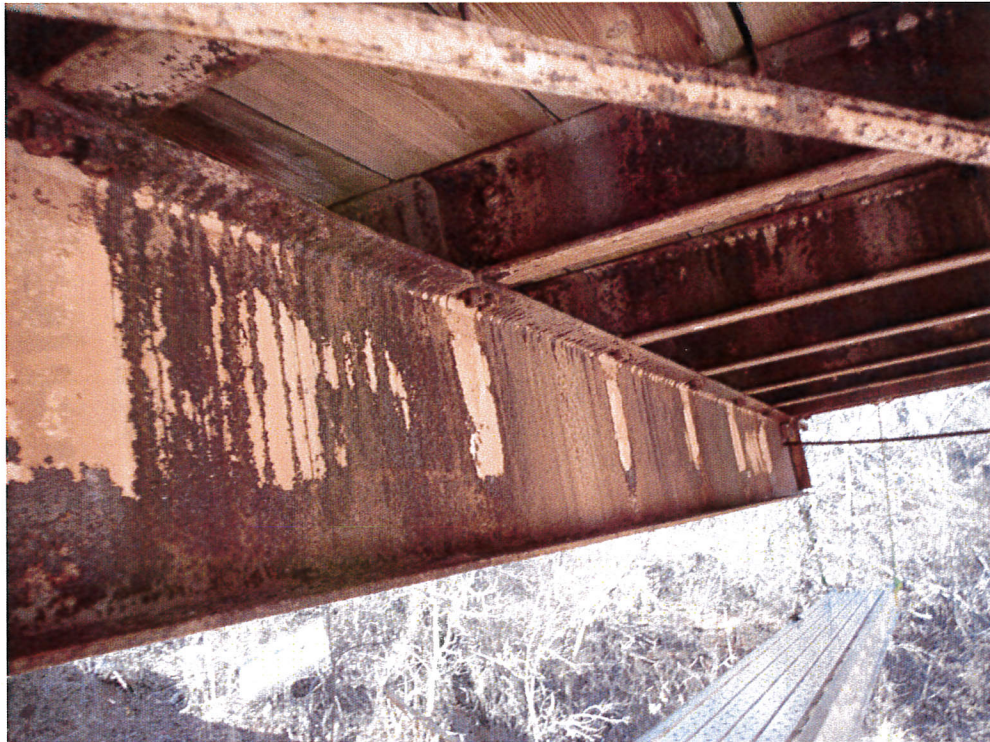
**[FCM] Floor Beams** (6, Satisfactory Condition) - Floor beams have minor freckled surface rust over 90 percent of the member surfaces. Floor beam FB2 and FB4 connections to the E. truss have negative threads on half of the bolts.

**Figure 7: Floor Beam 4 Overall Surface Corrosion**

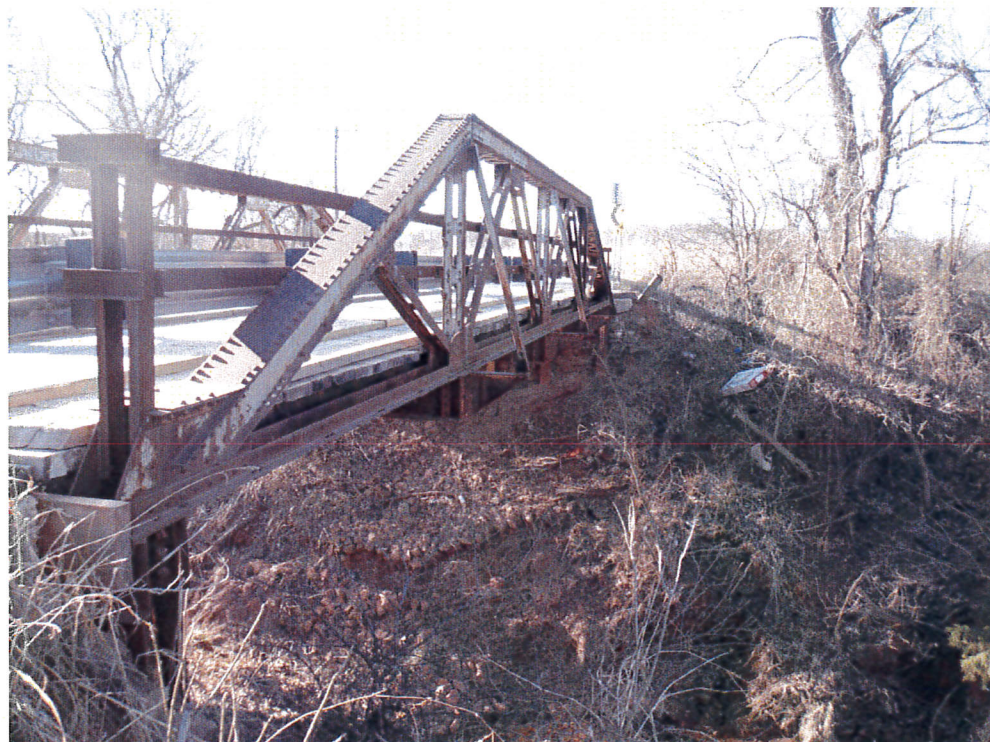
**Truss Upper Chord** (6, Satisfactory Condition) – The upper chord has minor pitting with freckled rust throughout on all surfaces.

**Figure 8: Typical Condition of Truss**

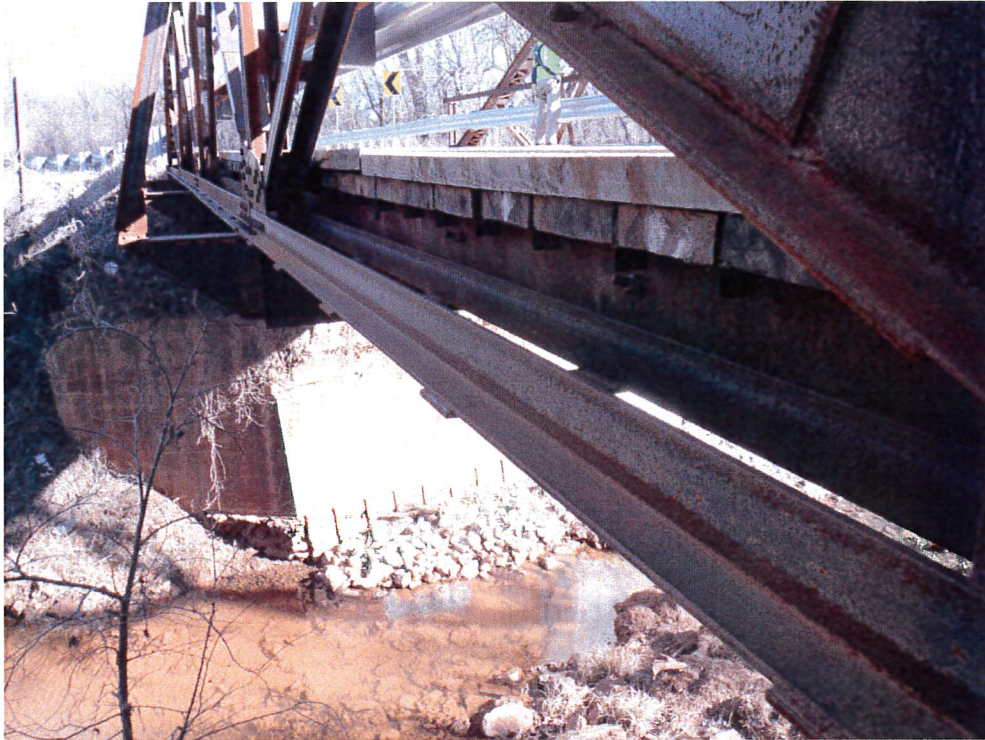
**[FCM] Truss Lower Chord** (5, Fair Condition) - The lower chord has minor pitting with freckled rust throughout on all surfaces. The lower chord L-channels have been replaced from L0 to L2 on the W. truss. The batten plates are welded to the L-channels and at L0 the leg of the L-channel is welded to the gusset plate.

**Figure 9: New Members of LC West Truss**

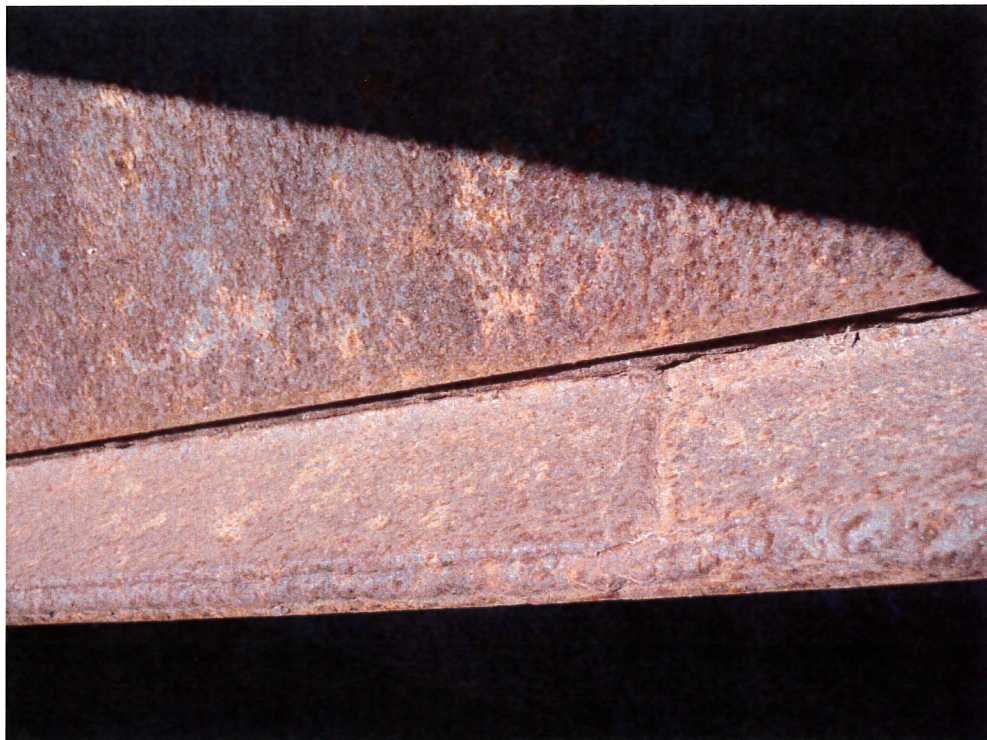
**Truss End Posts** (6, Satisfactory Condition) End Posts have minor pitting (up to 1/16'') with freckled rust throughout on all surfaces. The west truss end post L0-U2 has a repair to the top plate welded into place.

**Figure 10: Repair of West Truss End Post at South Abutment**

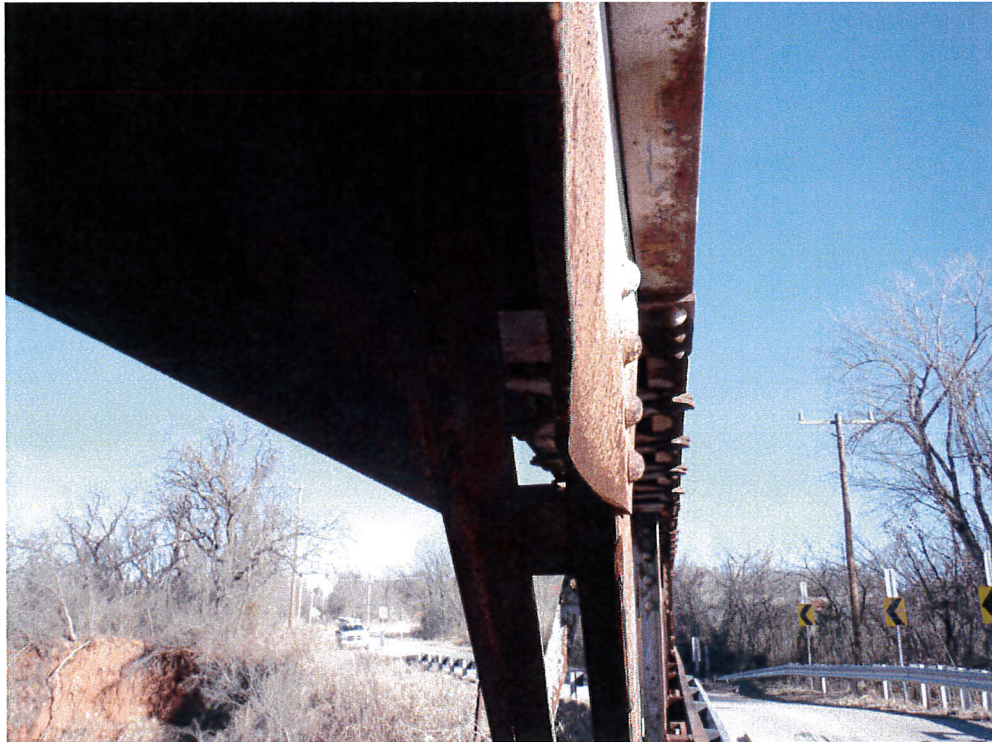
**[FCM] Truss Web Members** (5, Fair Condition) - Members exhibit minor pitting with freckled rust throughout on all surfaces. U3-L4 of W. Truss has minor impact damage and U3 gusset plate is slightly warped on W. Truss. Members U1-L2, U2-L2 and L2-U3 have been replaced on the W. Truss. The bridge railing has been welded to each web member of both trusses.

Figure 11: Warped Gusset Plate at U3, West Truss (From previous impact damage)

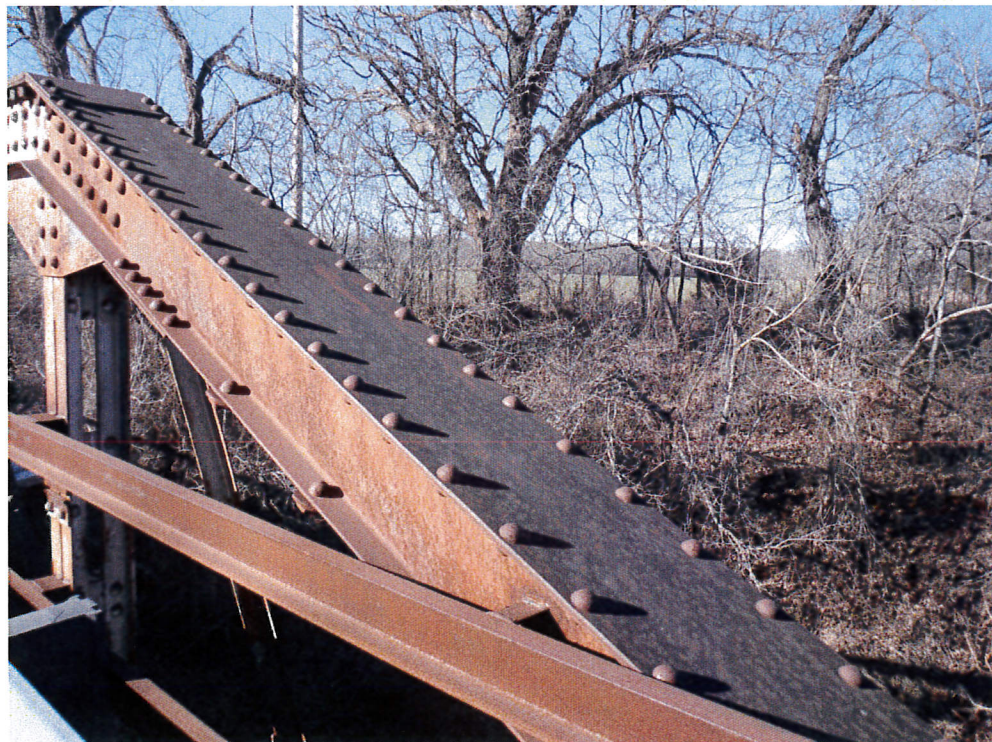
Figure 12: Bridge Rail welded to Truss Members

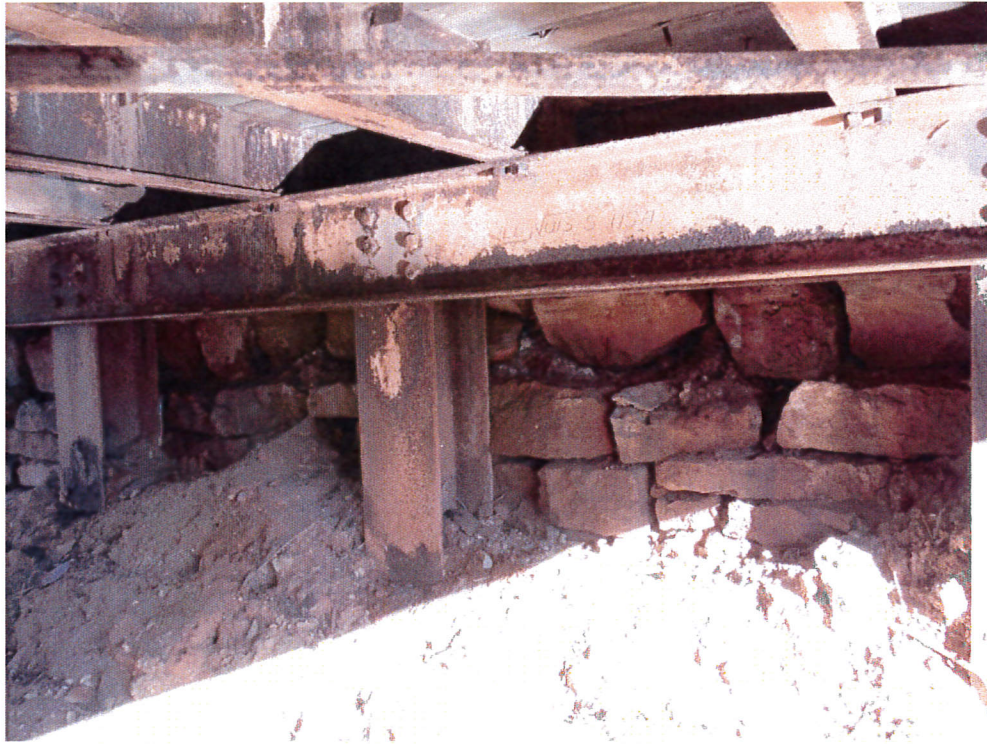
**Figure 13: Typical Corrosion of Steel Cap North Abutment**

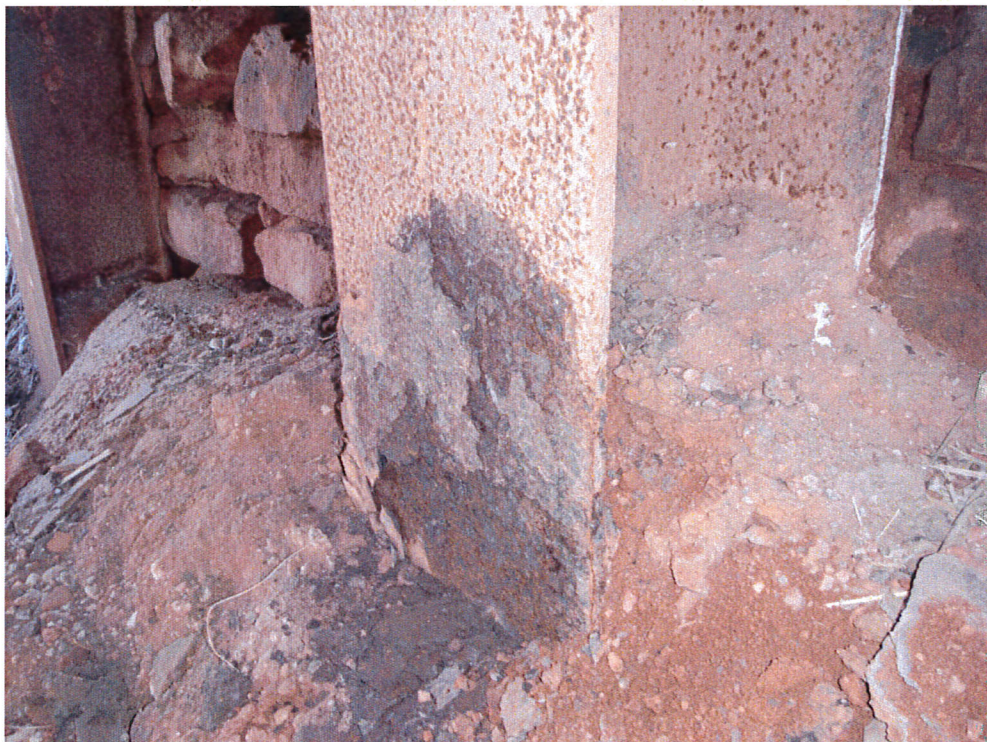
**Abutments** (5, Fair Condition) - PX – The steel pile and cap pier with masonry breast wall abutments are in fair condition. The steel piles and caps have freckled surface corrosion and minor pitting less than a 1/16''. There is section loss at the ground line of pile 2 of 15% and pile 3 of 20% due to laminated rust on front flanges of the North Abutment. The North and South stone masonry abutments are stable with minor soil piping occurring due to no mortar is present. The east stone wing wall has gaps of up to approximately 2 inches between stones. There are no wings at the north abutment. There has been a new retaining wall constructed on the NE corner and repairs of previous erosion completed.

**Figure 14: Typical up to 15% Section Loss of Pile 2, South Abutment**

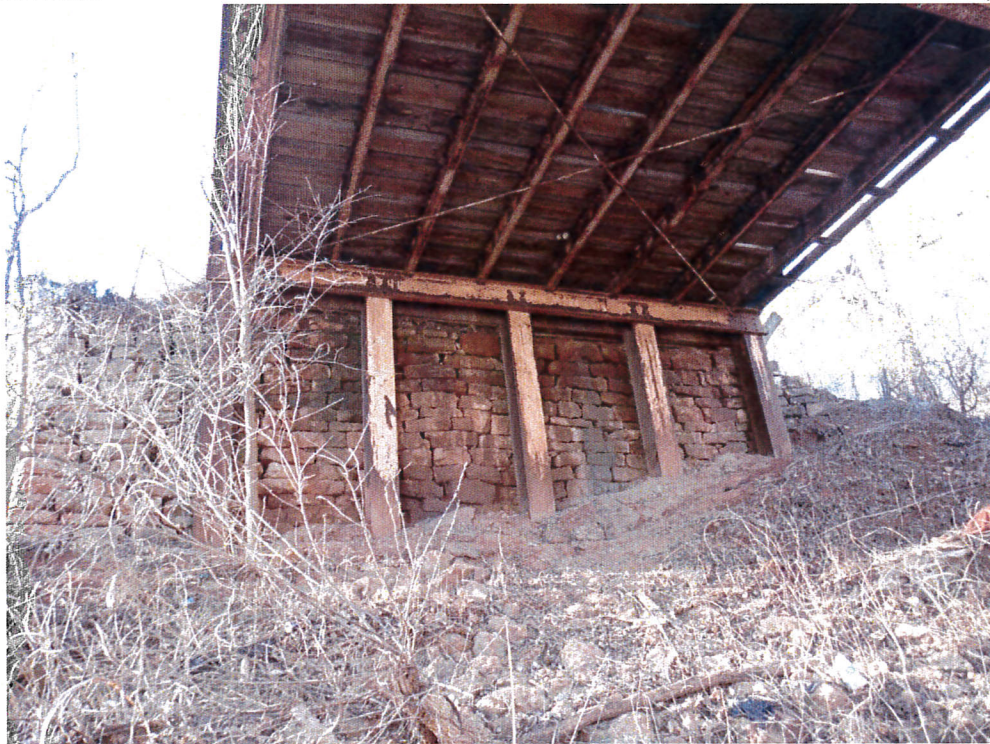
**Figure 15: Stone Masonry with Open Gaps South Abutment**

Elem.	Element Notes (Include Size and Location of Deterioration)
965	Debris build up exists downstream of bridge.
968	Erosion exists at south abutment east and west wings and at the west end of the north abutment.
970	PX - The east wing at the south abutment is settling resulting in open gaps between the stones.

PX – Monitor the south stone masonry abutment.

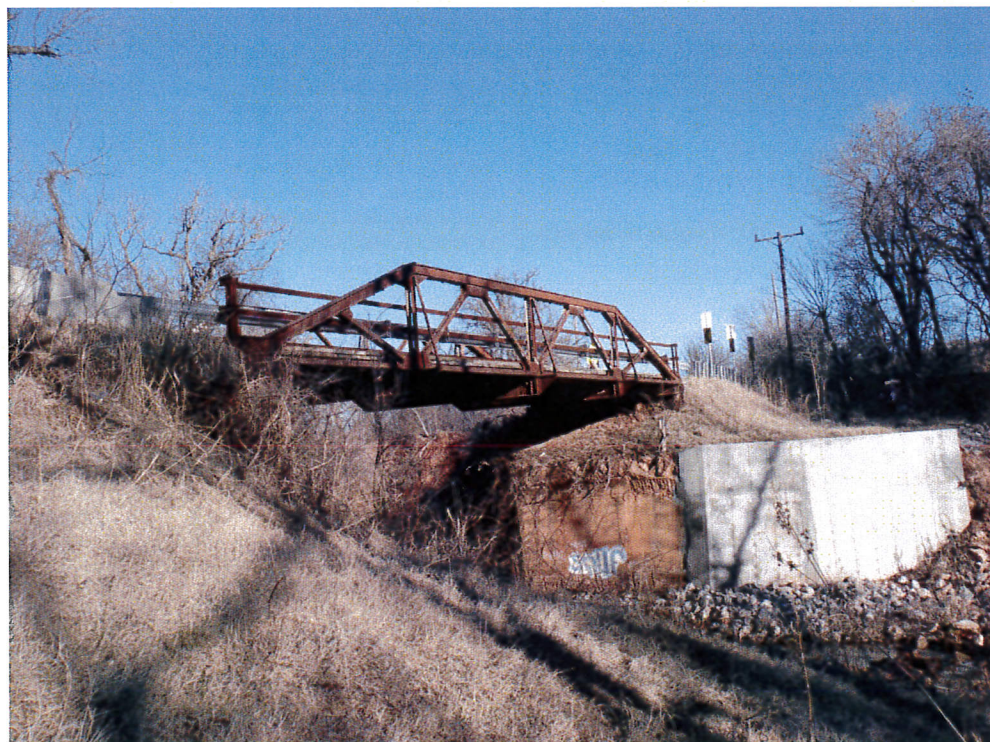
**Channel Scour** (4, Poor Condition) – Upstream and downstream banks are severely slumping along the channel. Debris exists downstream within the channel. There has been rip rap placed along the front edge of the bottom of the old north abutment beneath the bridge and the new retaining wall to stabilize the embankment in front of the North abutment.

**Figure 16: Old North Abutment and New Retaining Wall**
