# Fracture Critical Bridge Inspection Report

NBI Bridge No.: 03024

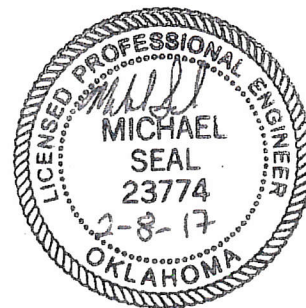
**SIGNIFICANT FINDINGS** are as follows:

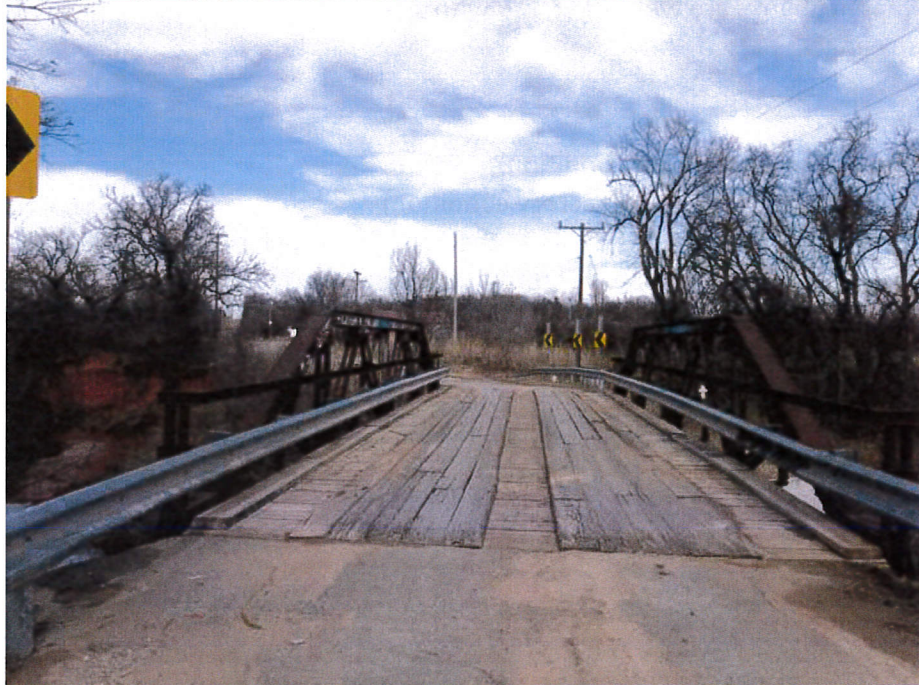
Photograph 1 - End view looking north.

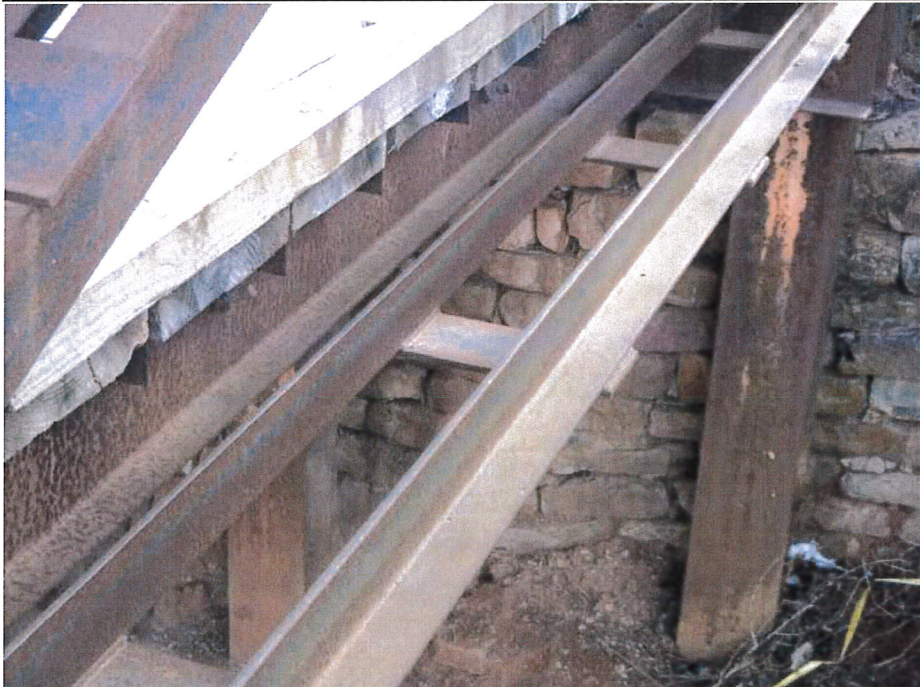
Photograph 10 - Looking southeast at west truss, lower chord. Note: L0L2 has been replaced with batten plates welded to lower chord in this section.

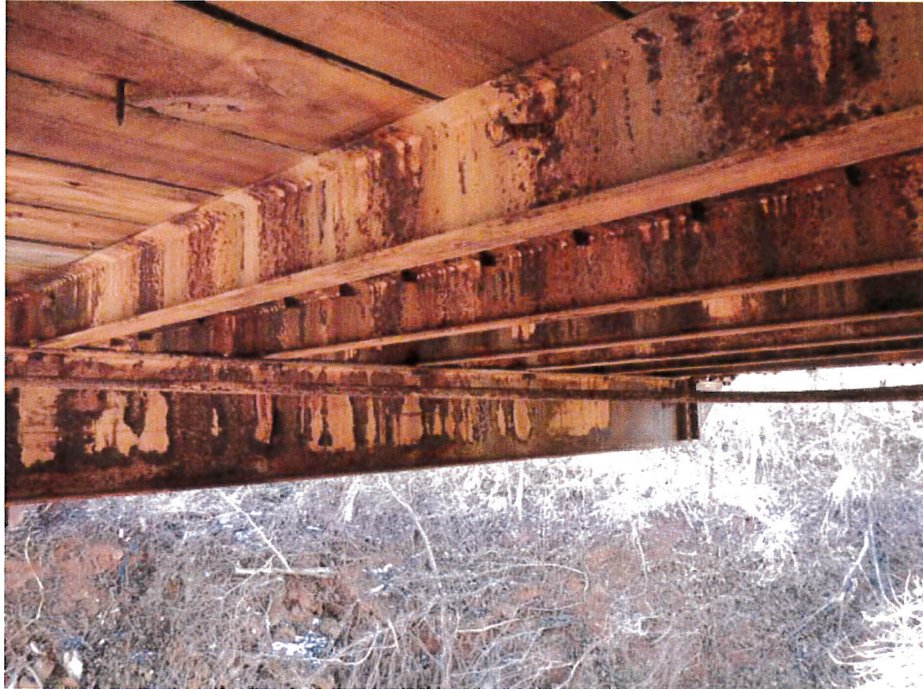
Photograph 11 - Looking southwest at overall typical condition of steel floor system with corrosion and failing paint throughout.

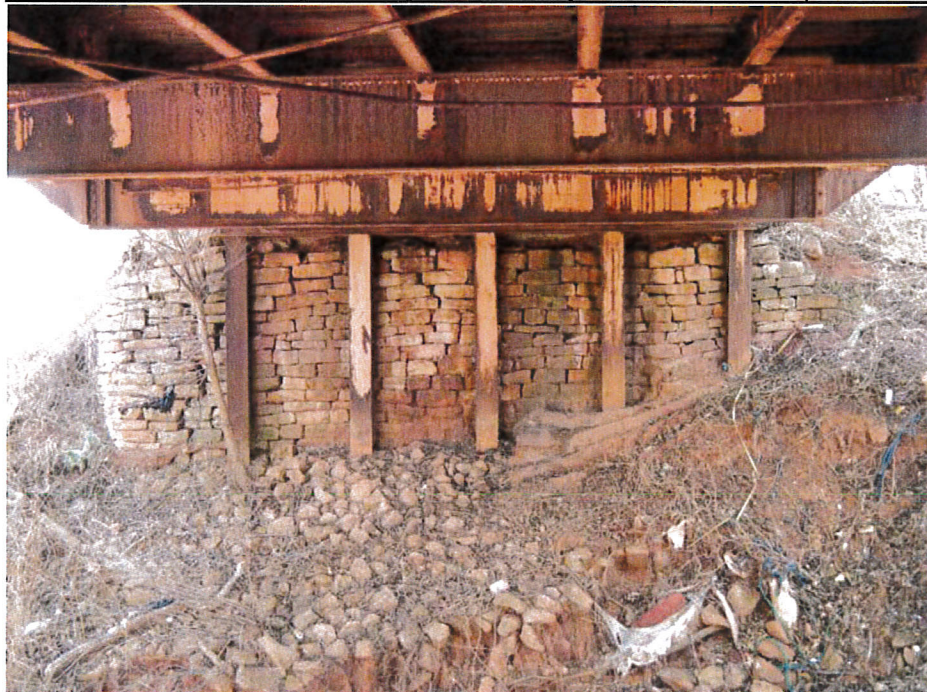
Photograph 12 - Looking south at overall view of north abutment breastwall. Note: Masonry blocks have no mortar between stones throughout abutment wall.

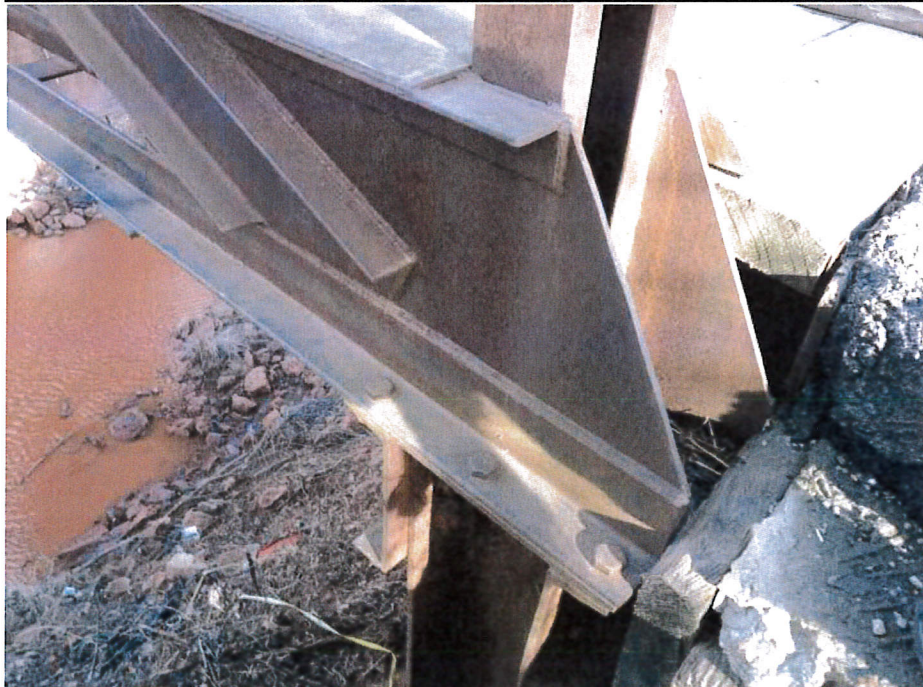
Photograph 14 - Looking northeast at L0, west truss. Note: The steel plate bearings exhibit surface corrosion with light amounts of minor pitting.

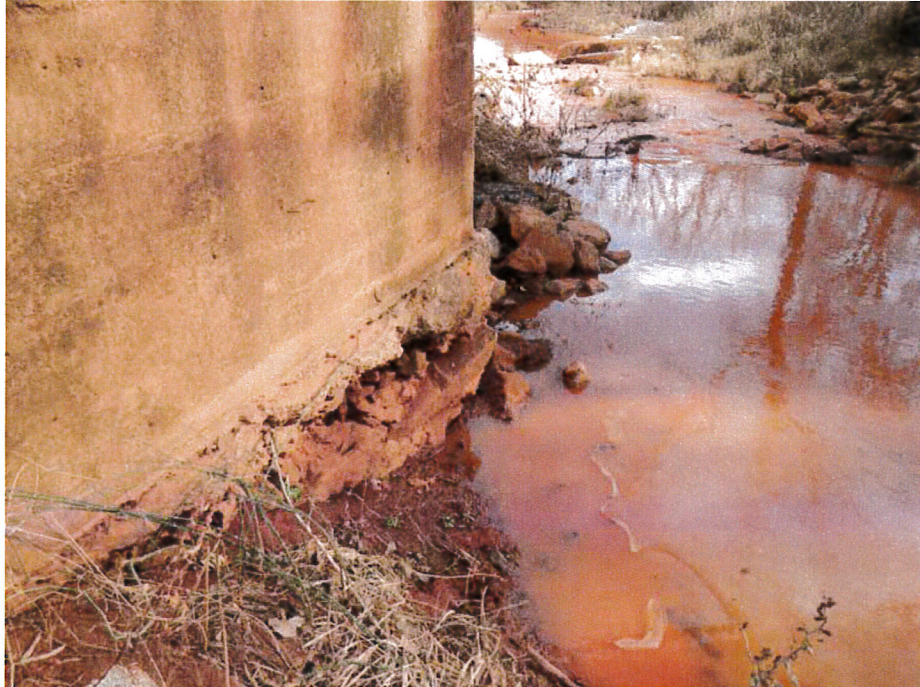
Photograph 15 - Looking southeast at base of the old concrete abutment in front of the current north abutment. Note: east end of old abutment has rock foundation exposed.

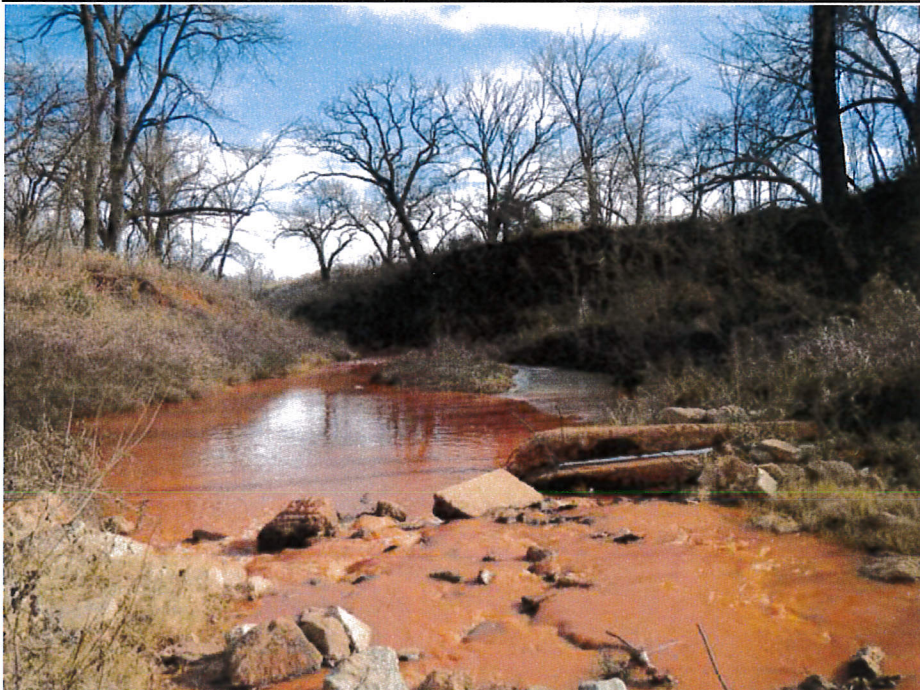
Photograph 16 - Looking east downstream of bridge. Note: channel slopes are sloughing heavily and washing out due to channel scour.
