**OKLAHOMA CITY FIRE DEPARTMENT  
FIRE PREVENTION SERVICES  
FIRE INVESTIGATION UNIT**

**ORIGIN AND CAUSE REPORT WRITTEN BY FIRE INVESTIGATOR J. HOFFMAN:**

**OKC Fire Suppression Incident Number (ERS#): 2022-10149**

**Incident Address:** 6161 N Western Ave.  
Oklahoma City, OK 73118

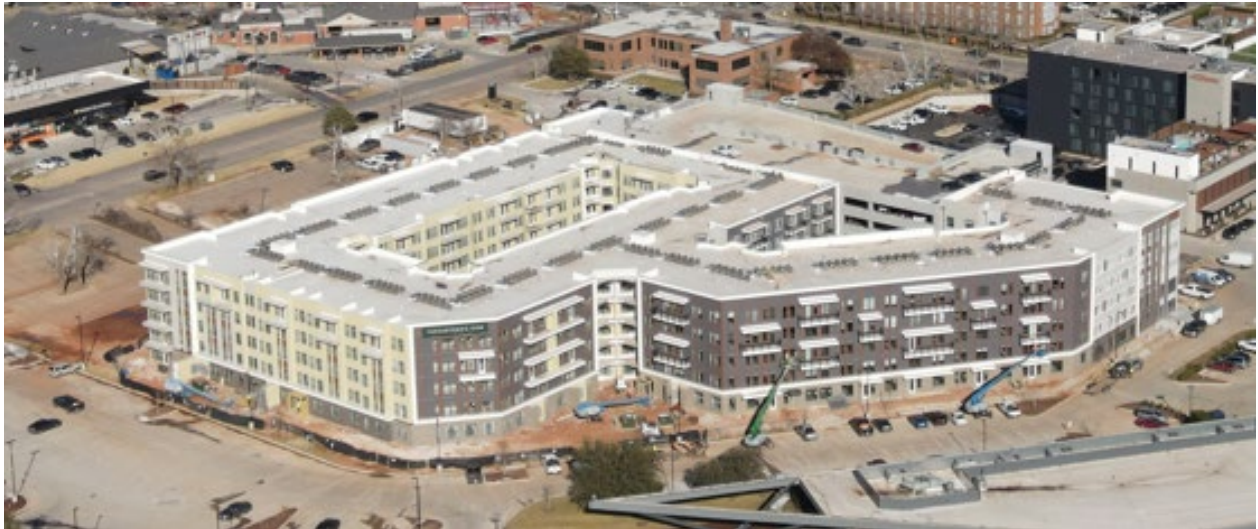
6161 N Western Ave., Oklahoma City, OK (Pre-Fire Photo)

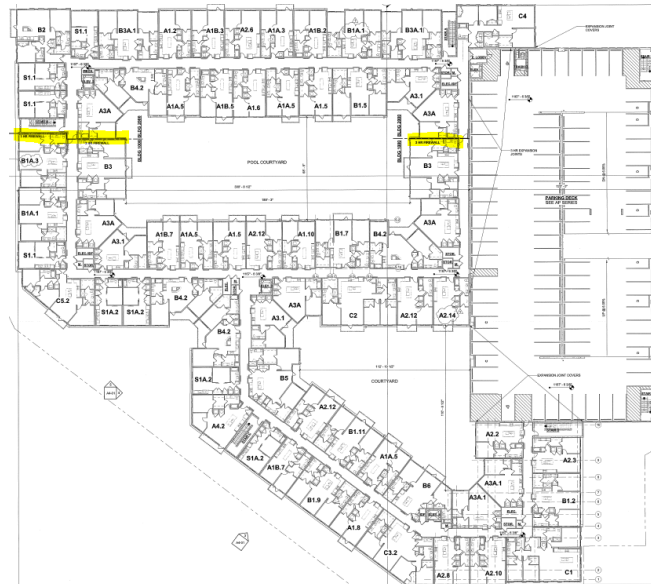
Highlighted Areas with 3-Hour Fire Walls

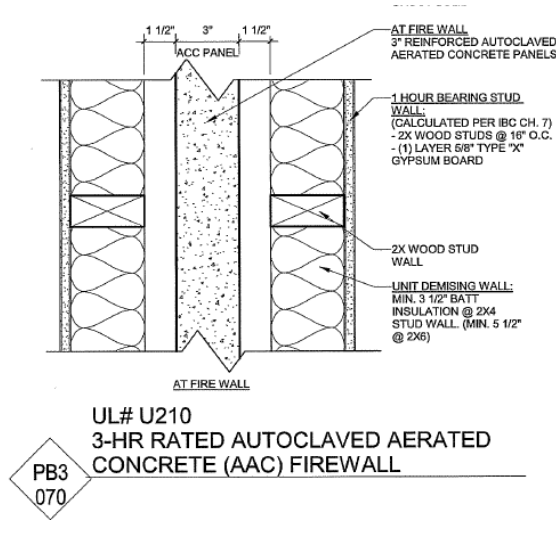
3 Hour Firewall Construction Details from the building plans

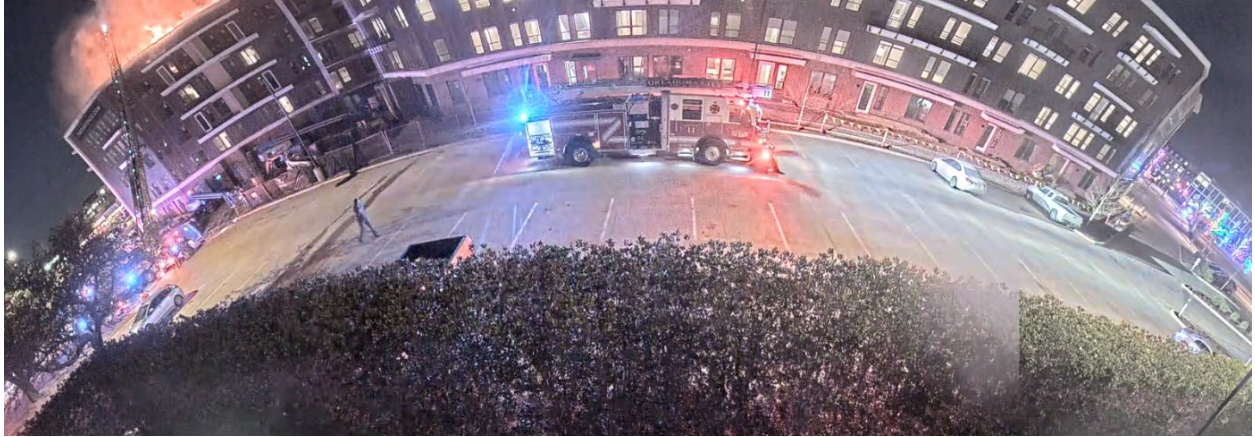
Picture from video from the Washington Prime Group

The fire on the roof quickly spread to the east (as the wind was blowing in that direction).

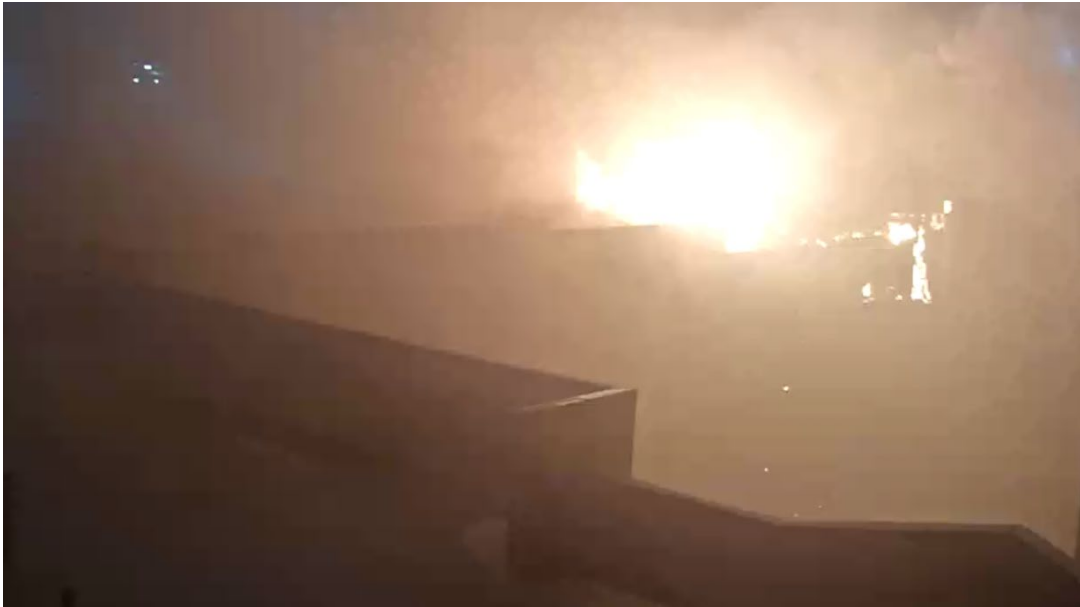
Pictures from video provided by CMS Willowbrook. The camera is located on the north side of the parking garage and is facing southwest.

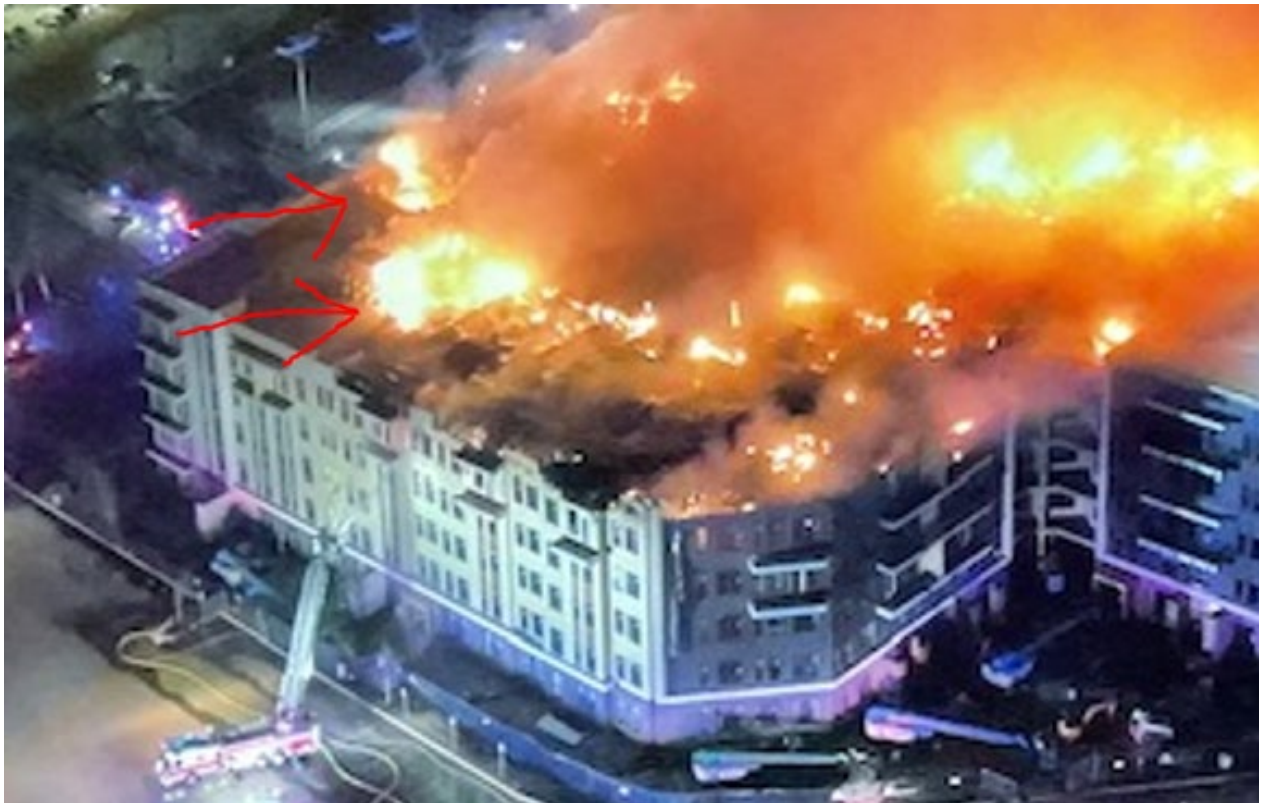
The fire broke through the roof at two other locations, near the northwest area of the building on the other side of the firewall.

Pictures taken with city issued iphone from helicopter news footage.

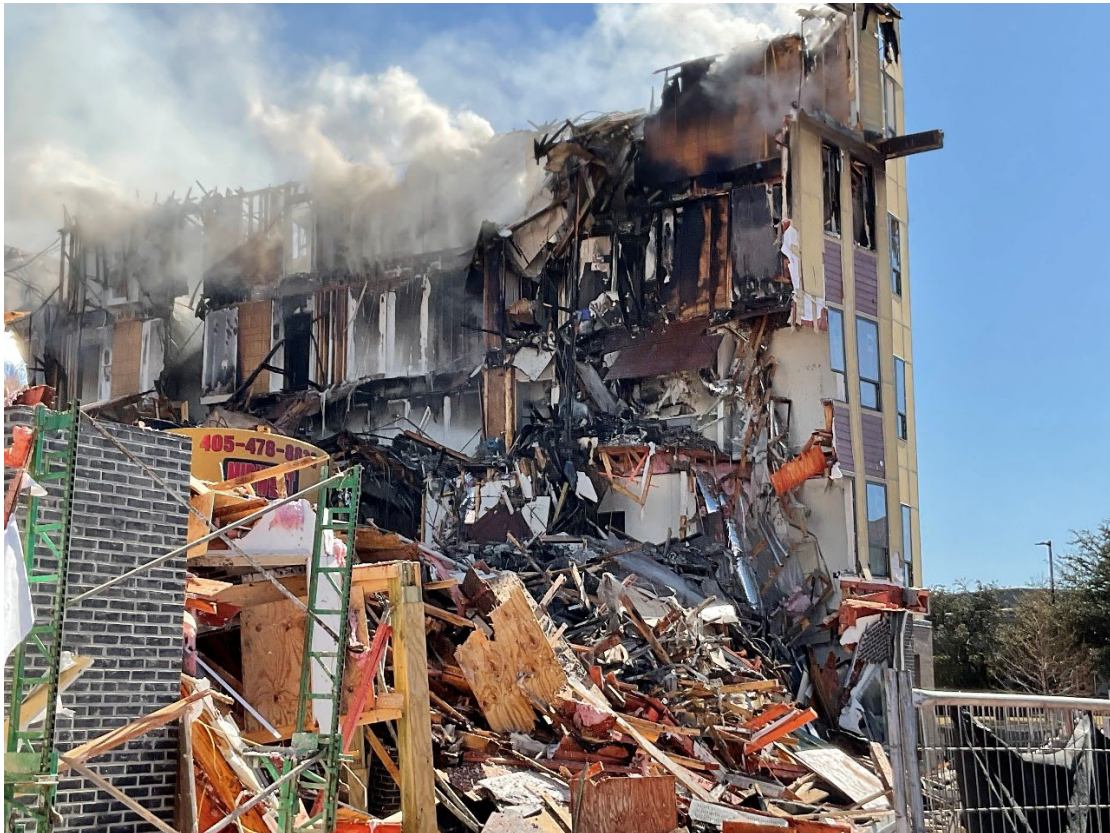
I was on scene several times while the building was being demolished to take photographs and look at debris. When the excavator was demolishing the southwest area, I observed the twenty-four-inch interstitial space between floors 3 and 4 had

Photo taken with city issued iPhone. Picture of southwest area facing southeast.

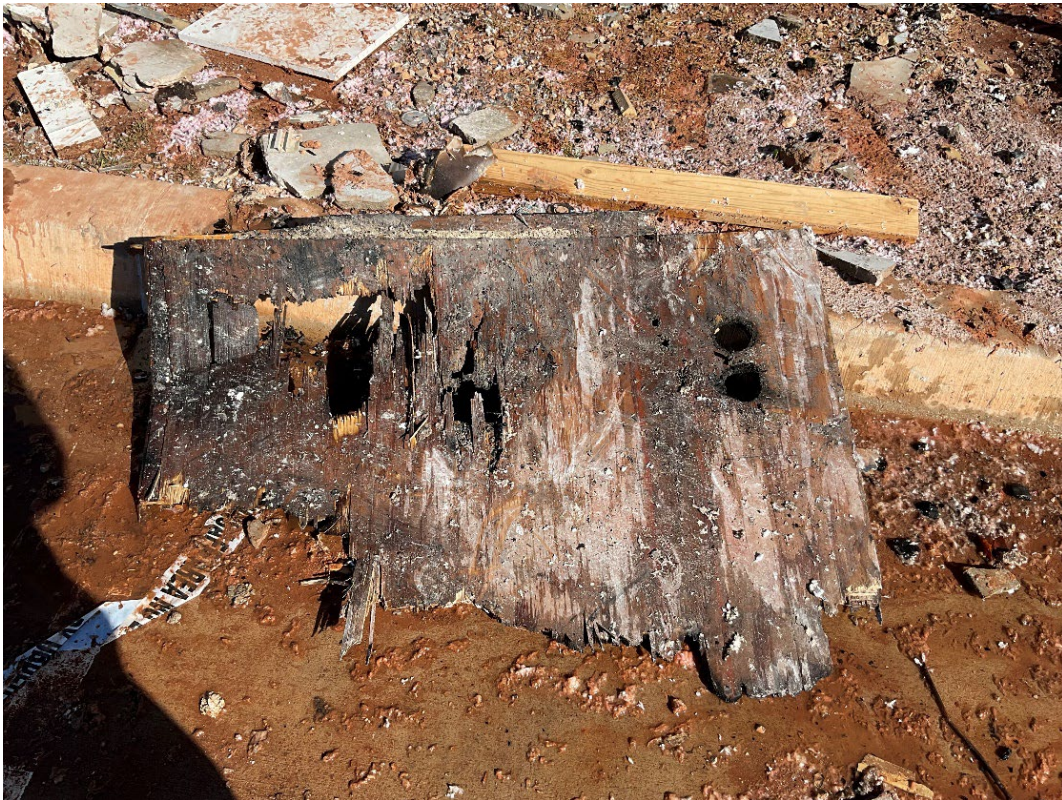
extensive charring, but the rooms above & below the interstitial space had not caught on fire. I also retrieved a electric sub-panel with the conductors & conduit which had run down beneath the floor. The flooring the conduit and conductors had run into was also retrieved. The flooring was not burned on the top but was heavily charred on the bottom. The sub panel was damaged from the demolition but had no signs of flame impingement or soot deposits. The conduit had also melted away along with the insulation sleeve from the conductors inside the interstitial space. I also observed burning in the interstitial space between the fourth and fifth floor. (See the following four pictures).

Top of flooring from 4<sup>th</sup> floor electrical room; southwest area of building

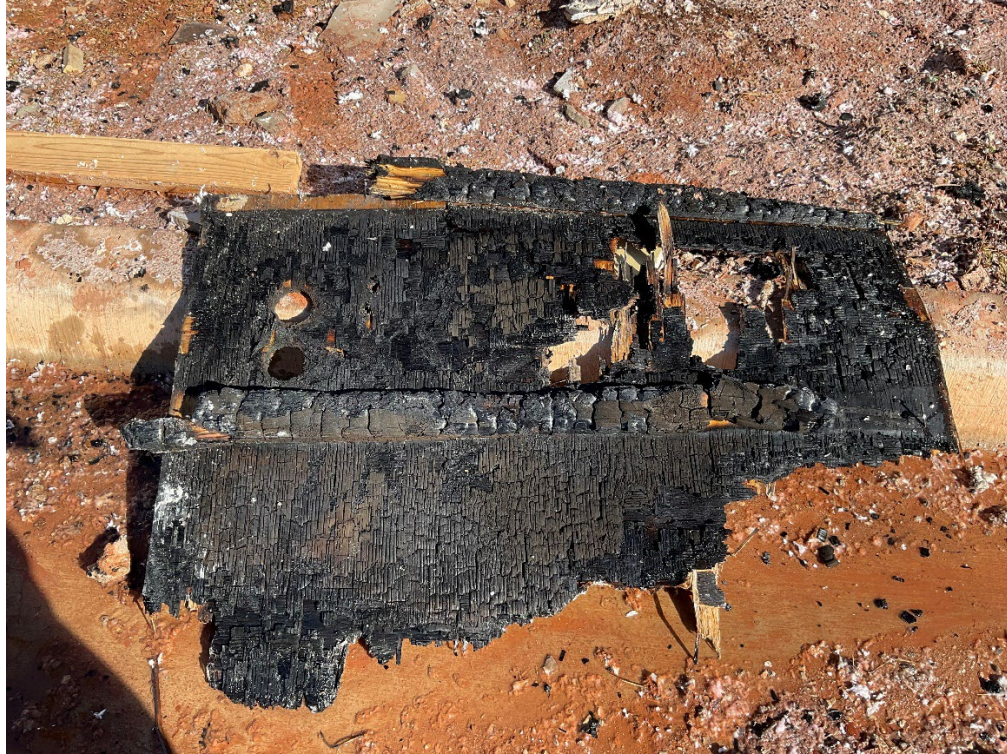
Bottom of flooring from 4<sup>th</sup> floor electrical room; southwest area of building

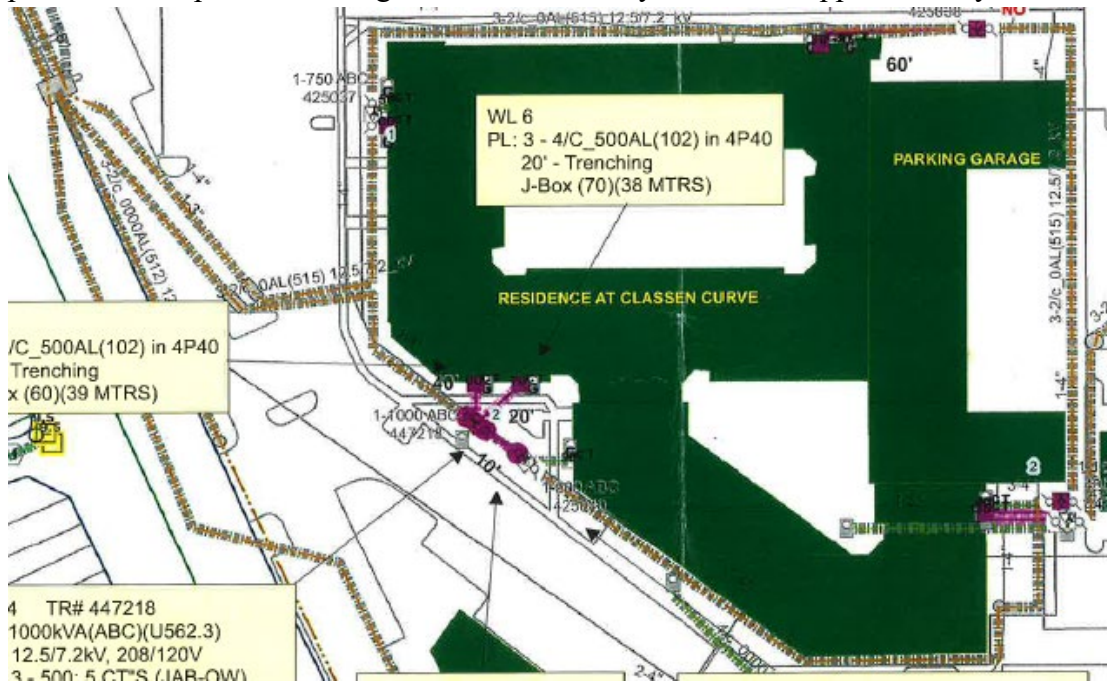
The structure was supplied by three-phase electrical service having five pad mounted electric transformers and six service laterals to six disconnect boxes/meter bases. The five transformers were connected in series (Figure 1). An interview with the manager of Red Dirt Construction's manager, [REDACTED] (sub-contractor for OG&E), advised his company did work on the transformer on the west side of the building and turned the power on to it prior to leaving the site on February 8, 2022, at approximately 1600 hours.

(Figure 1) Diagram showing all of the five transformers were connected in series.

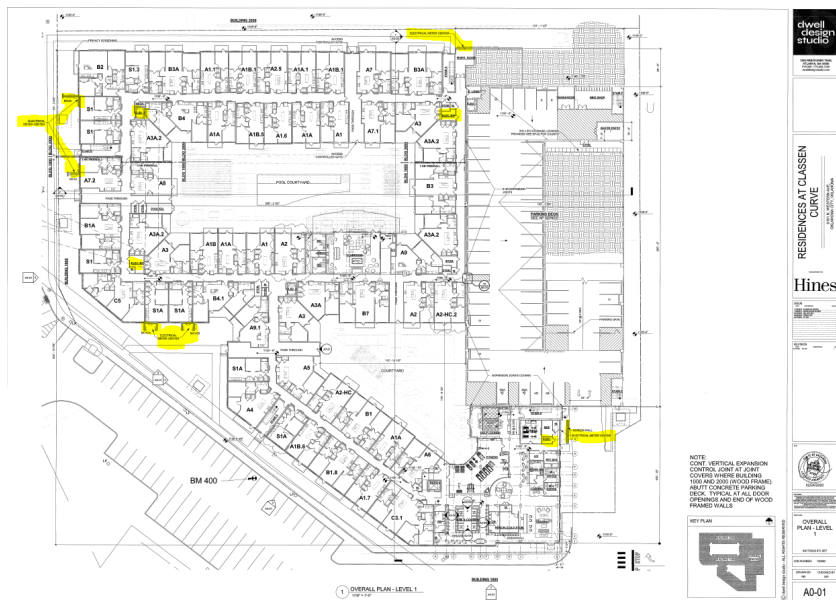
(Figure 2) LEVEL 1: Highlighted Electrical Meter Centers and Electrical Rooms

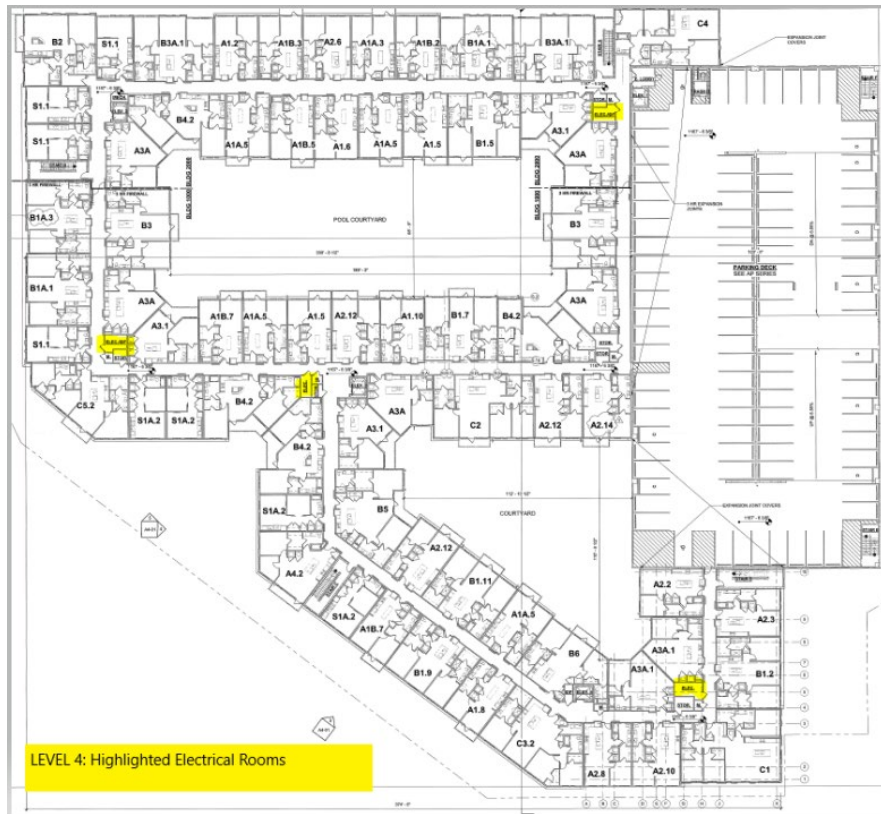
(Figure 3) Level 4: Highlighted Electrical Rooms

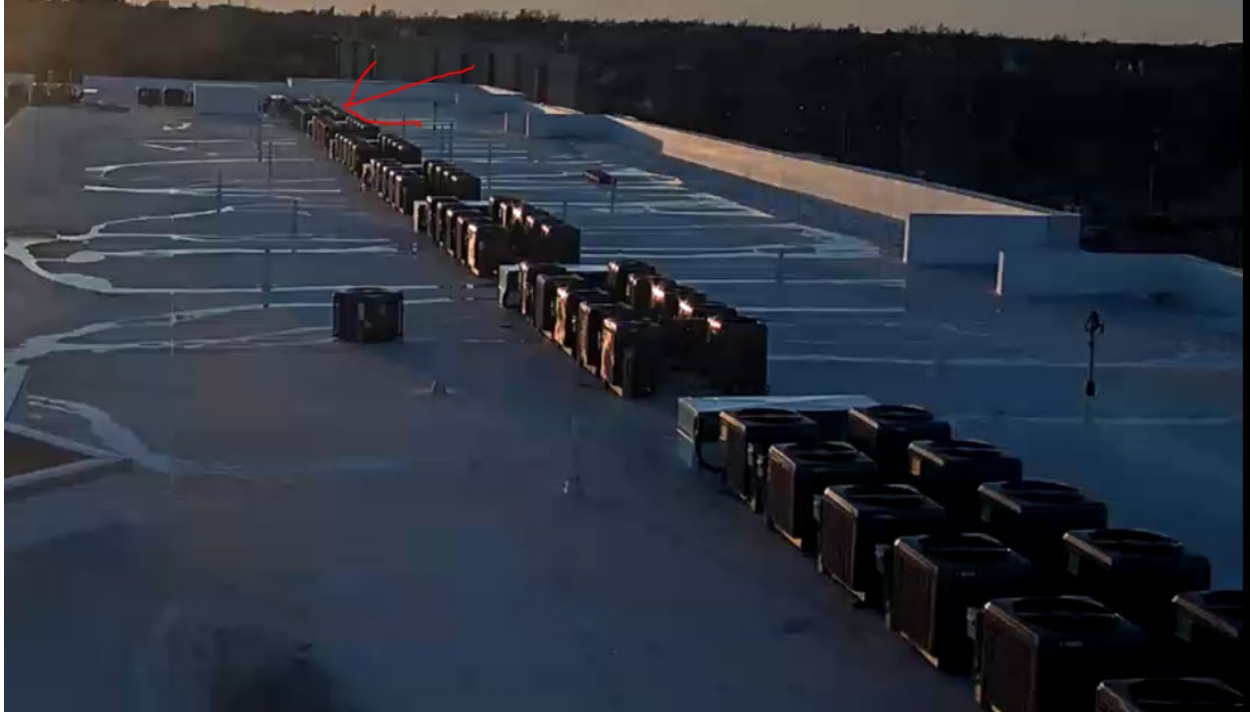
Fire burned through the roof on the southwest area of the building and spread eastward. Fire then burned through the roof on the northwest area of the building, across a firewall. This was seen on video footage. Video footage (from CMS Willowbrook) from a camera which was on the north side of the parking garage shows light white smoke visible on the northwest area of the roof at 1847 hours (The video footage is one hour ahead; actual time is 1747 hours). This time is forty-six minutes prior to the 911 call.

White smoke seen coming from this area at 17:47 hours
