**OKLAHOMA CITY FIRE DEPARTMENT
FIRE PREVENTION SERVICES
FIRE INVESTIGATION UNIT
2300 General Pershing Blvd.
Oklahoma City, OK 73107
405-297-3321**

**SUPPLEMENTAL ADDENDUM TO
ORIGIN AND CAUSE REPORT WRITTEN BY FIRE ASST. FIRE MARSHAL J. HOFFMAN:**

Date Written: July 18, 2022
OKC Police RMS Number: N/A
OKC Fire Suppression Incident Number (ERS#): 2022-10149

Incident Date: February 8, 2022
Incident Address: 6161 N Western Ave.
Oklahoma City, OK 73118

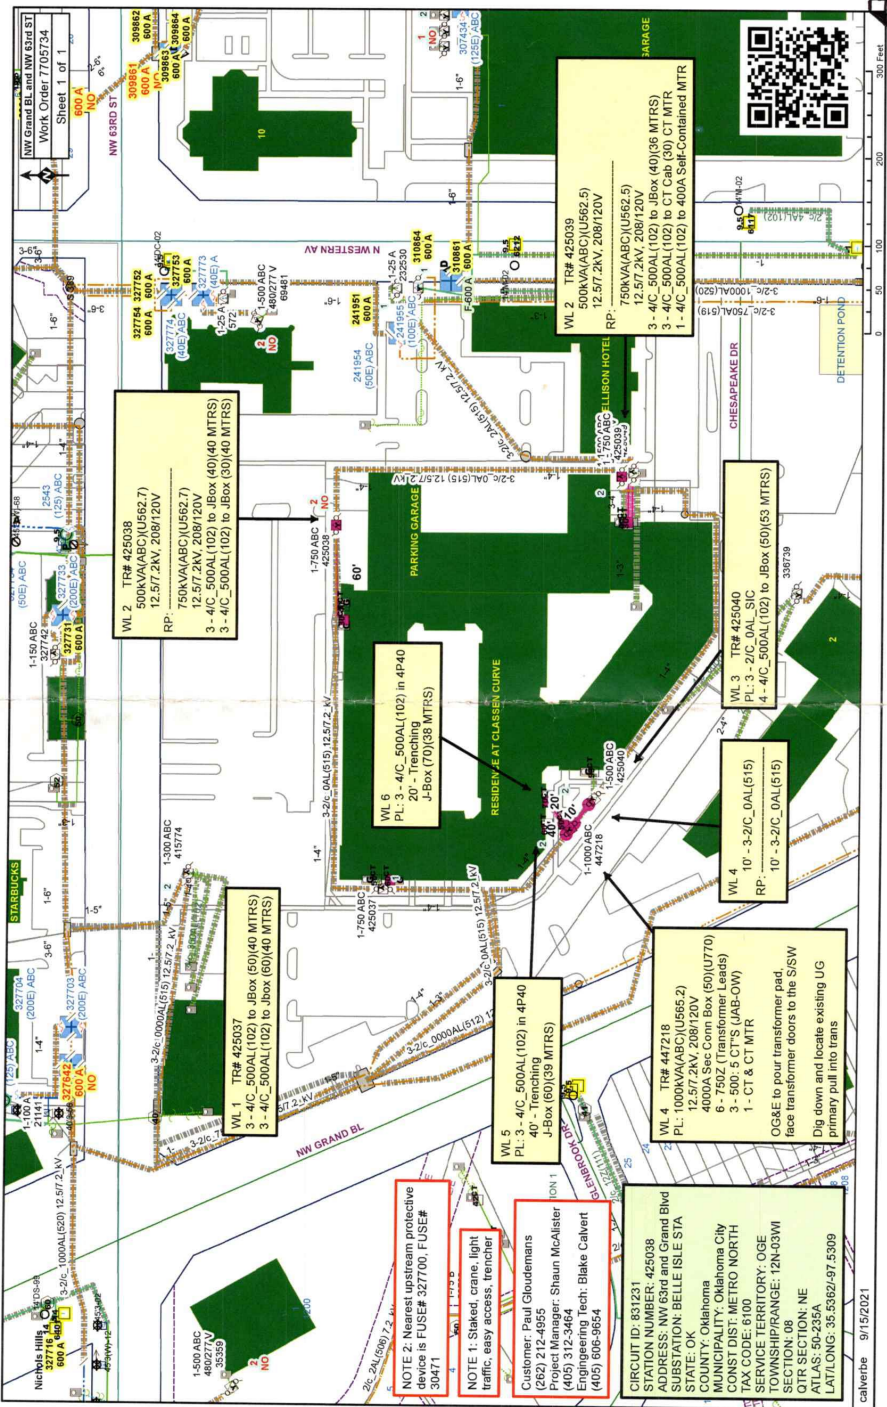
I have highlighted (blue) the transformers that were involved in switching order M0196 I also placed notes and highlighted (red) next to the transformers in the order they were switched

Transformer 425037 is energized by two primary cables one from 425038 and one from 415774 so when you open these two primary cables this de-energizes 425037
