LOI SUPPORTING DOCUMENTATION FOR WC-1039

EXCERPT FROM WY-0002/SY-0003 REPORT  
*ARC FLASH SUMMARY & FIELD INVESTIGATION EVALUATION*

## 5.0 FIELD INVESTIGATION EVALUATION

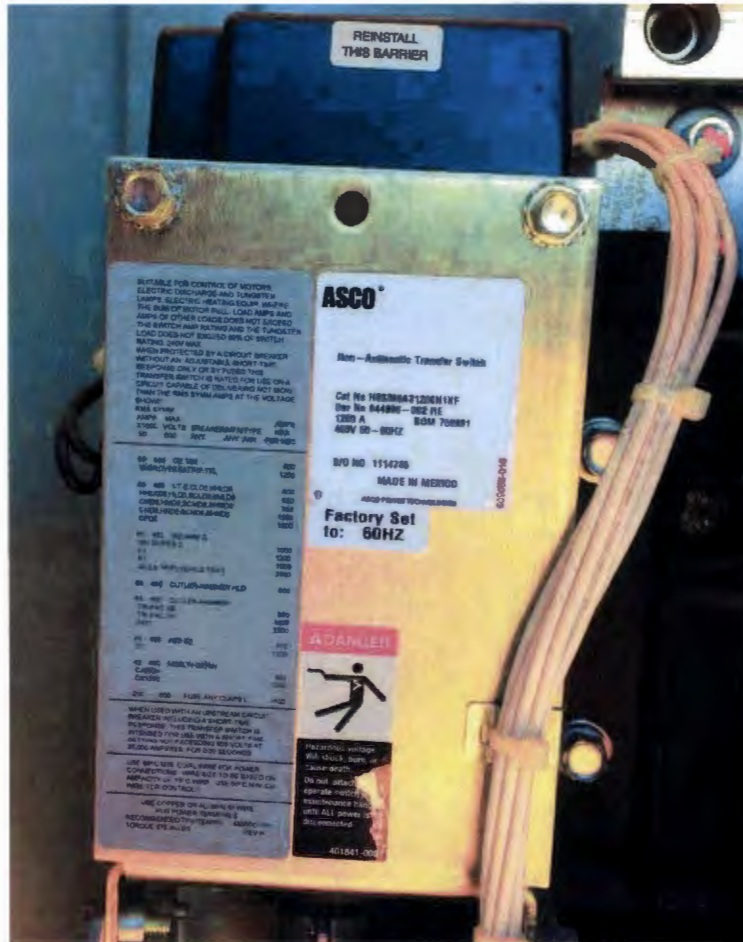
Photo 1 - MTS Nameplate

- The majority of these pump stations have a manual transfer switch (MTS) that acts as a service-entrance disconnect switch. Each MTS has a nameplate that indicates a short circuit current rating based on an upstream overcurrent protection device. However, most of the facilities do not have an overcurrent protective device upstream of the MTS. Therefore, it is unclear how to assign a short circuit current rating for the MTS.

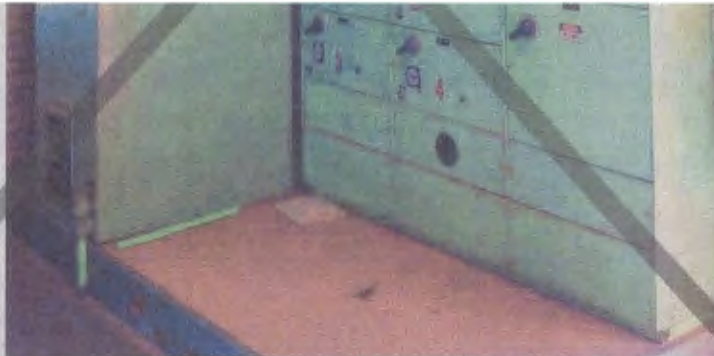
Photo 2 - PS #7 Electrical Gear

At Pump Station #7, the electrical distribution gear is very old and is scheduled to be replaced within 1 year. The General Electric MCC was installed around 1957. The circuit breakers were not modeled as a part of this study. When the existing equipment is replaced, an updated study will need to be performed.

**NO PROJECTS NEEDED, BOOSTER PUMP STATION SCHEDULED FOR DEMOLITION**

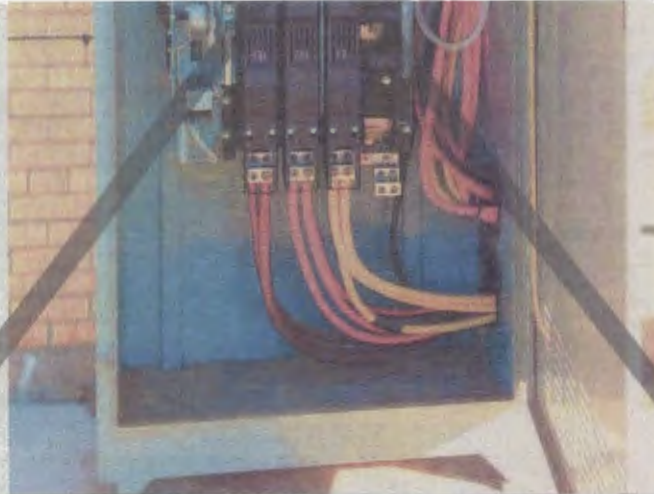
**Photo 3 - PS #8 MTS**

- At Pump Station #8, the utility service enters the facility through a MTS. This switch does not have any overcurrent protection. Additionally, the incoming neutral conductor is not bonded to ground at this MTS. To comply with NEC 230.91, it is recommended that a service-entrance rated overcurrent protective device be installed between the utility transformer and the MTS. Adding overcurrent protection between the secondary of the transformer and the major electrical equipment in the pump station could reduce arc flash energy at the downstream equipment and improve safety at the facility.

**NO PROJECTS NEEDED, BOOSTER PUMP STATION NOT IN SERVICE**

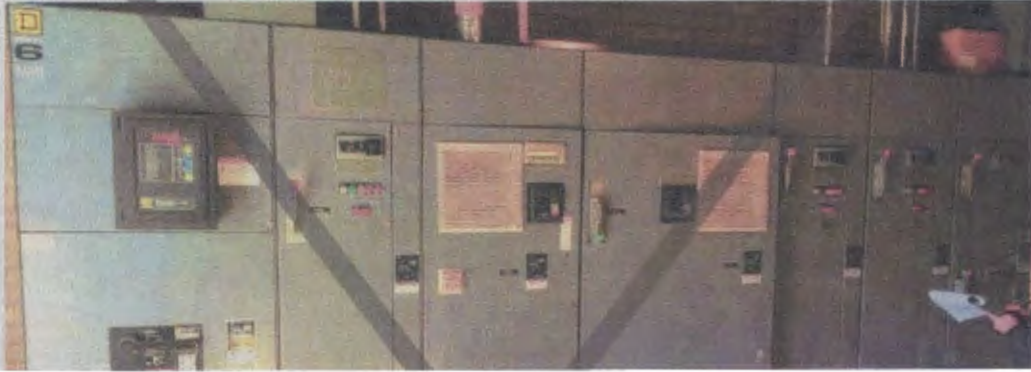
Photo 4 - PS #8 MCC

• At Pump Station #8, there are two variable frequency drives (VFDs) that control the 150 hp and 250 hp motors. These VFDs have a tendency to shut down in summer months from overheating. Electrical equipment that frequently overheats can experience reduced operational life, which creates reduced liability of the pump station. Carollo recommends the City consider Heating, Ventilation, and Air Conditioning (HVAC) modifications to this pump station to improve reliability and increase the life of the electrical equipment.

**NO PROJECTS NEEDED, BOOSTER PUMP STATION NOT IN SERVICE**

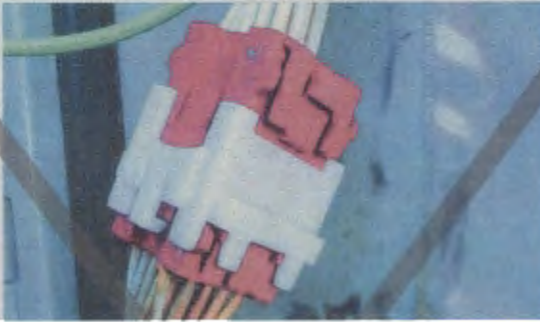
Photo 5 - PS #10 MTS Control Wiring

- At Pump Station #10, the utility service enters the facility through a MTS. This switch does not have any overcurrent protection. To comply with NEC 230.91, it is recommended that a service-entrance rated overcurrent protective device is installed between the utility transformer and the MTS. Furthermore, the control wiring in this switch enclosure shows burn marks, and there is evidence of water damage in the bottom of the enclosure. The wiring should be tested and repaired to ensure proper operation of the equipment and reduce safety concerns.

**NO PROJECTS NEEDED, BOOSTER PUMP  
STATION NOT IN SERVICE**

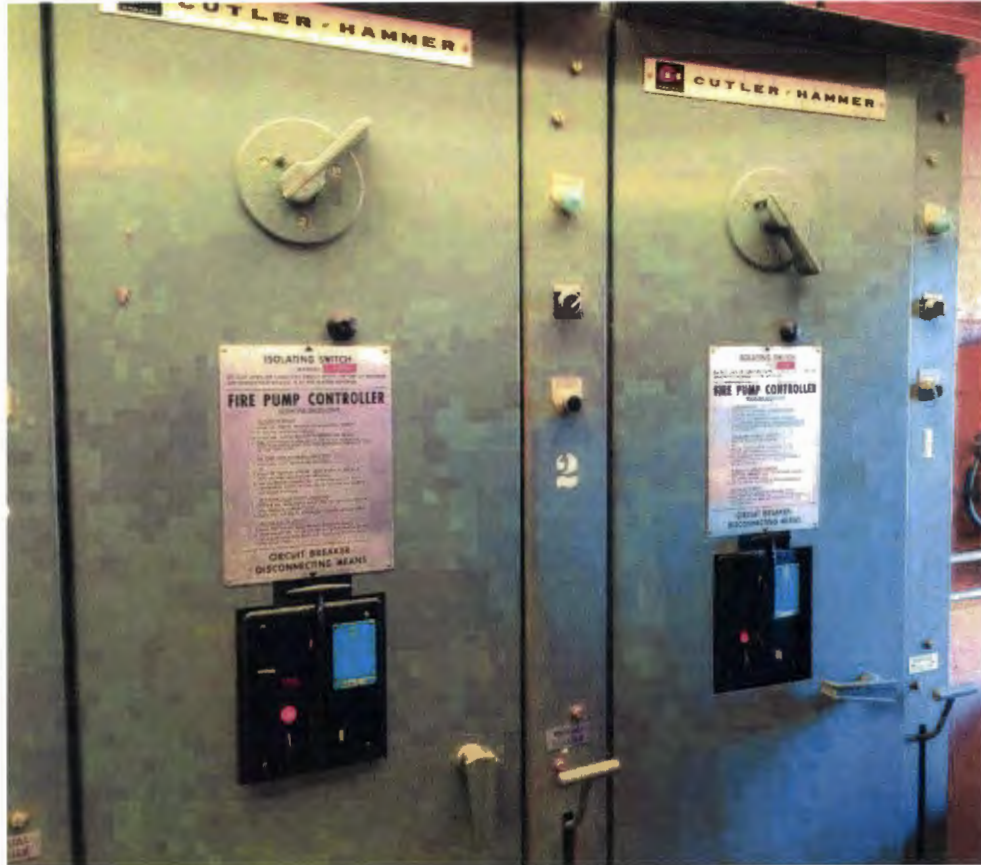
Photo 6 - PS #11 Fire Pump Starters

- At Pump Station #11, the fire pump motor starters are very old and have not been serviced in a long time. The breakers would not close under normal operation, and had to be forced closed. These starters should be replaced immediately to increase reliability and reduce safety concerns.

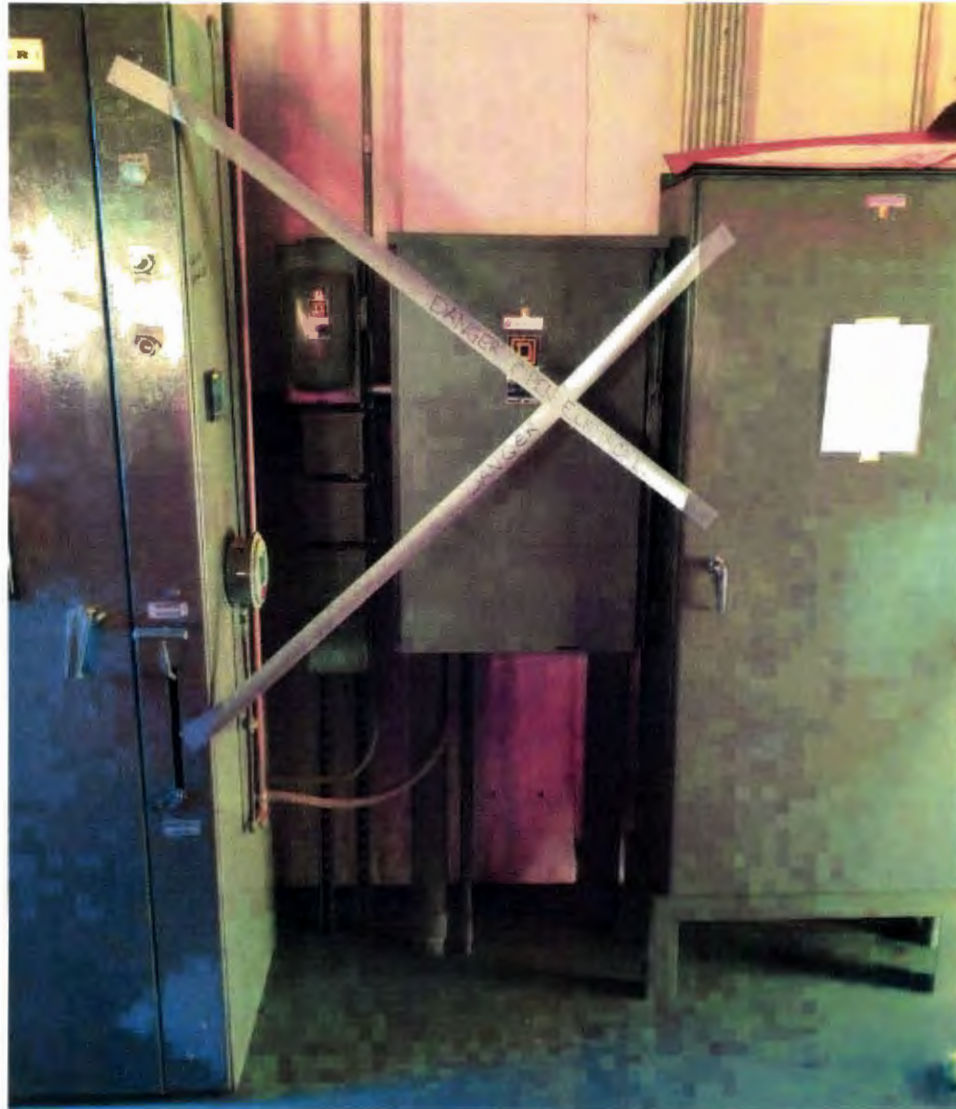
Photo 7 - PS #12 Main Disconnect

- At Pump Station #12, the main disconnect was opened for inspection and would not close. The disconnect was then forced closed and deemed a significant safety hazard. This disconnect switch should be replaced immediately to increase reliability and reduce safety concerns. The fire pump motor starters are also very old, have not been serviced in a long time, and should be replaced.

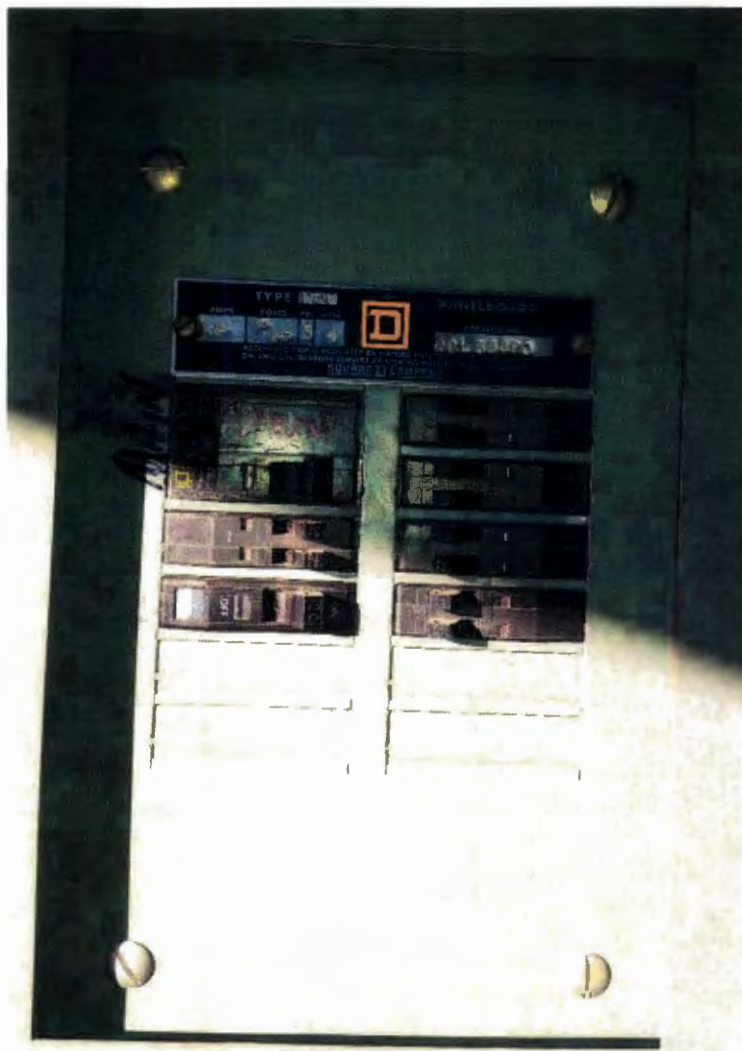
**Photo 8 - PS #12 Lighting Panel**

- At Pump Station #12, the lighting panel had a "burnt" odor and has likely been on fire in the past. This represents reliability and safety concerns. Carollo recommends replacement as soon as possible.

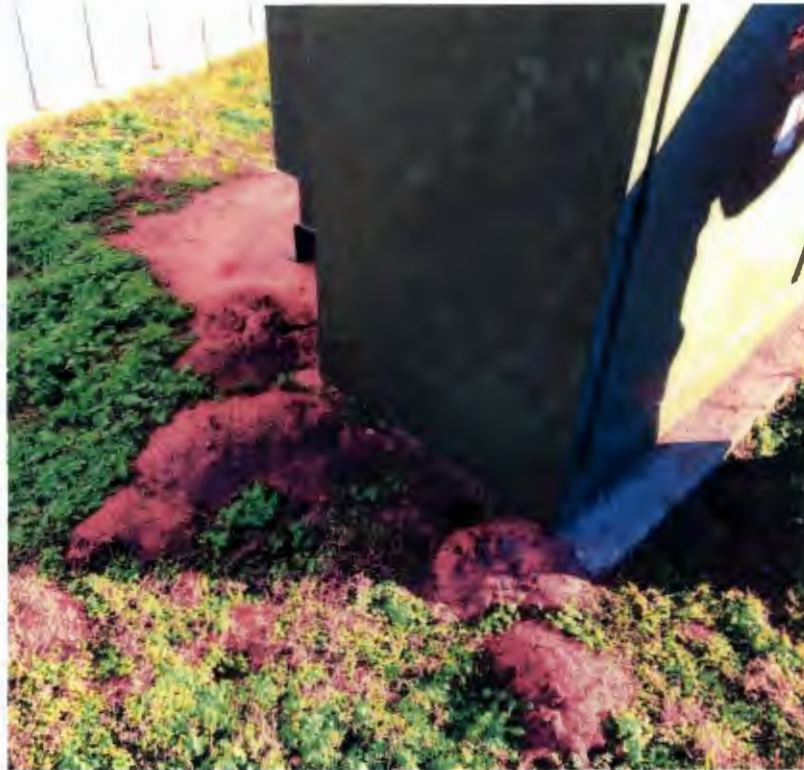
**Photo 9 - PS #12 Utility Transformer**

- At Pump Station #12, the utility transformer is on a concrete pad that appears to be settling into the soil. It is recommended that the foundation be repaired so that damage does not occur to the transformer or electrical infrastructure of the service entrance conductors. As this transformer is OG&E's equipment, we recommend that the City contact OG&E and inform them of this condition.

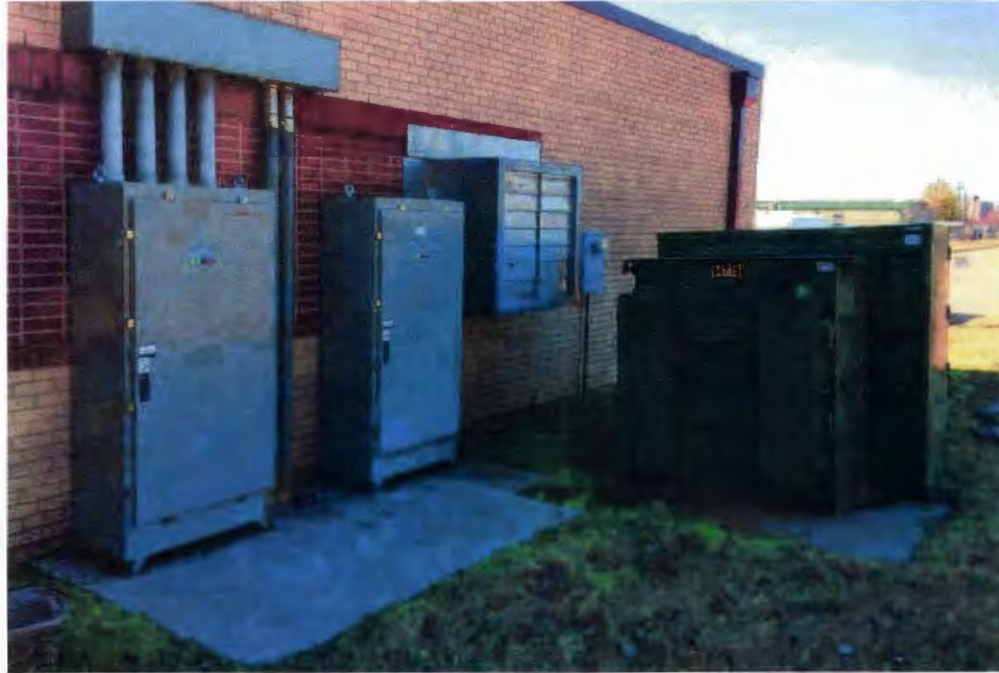
**Photo 10 - PS #15 Service-Entrance Equipment**

- At Pump Station #15, the utility service enters the facility and is brought to two MTSs. These switches do not have any overcurrent protection. Additionally, there are no incoming neutral conductors from the service transformer. To comply with NEC 230.91, it is recommended that a service-entrance rated overcurrent protective device be installed between the utility transformer and the MTSs.

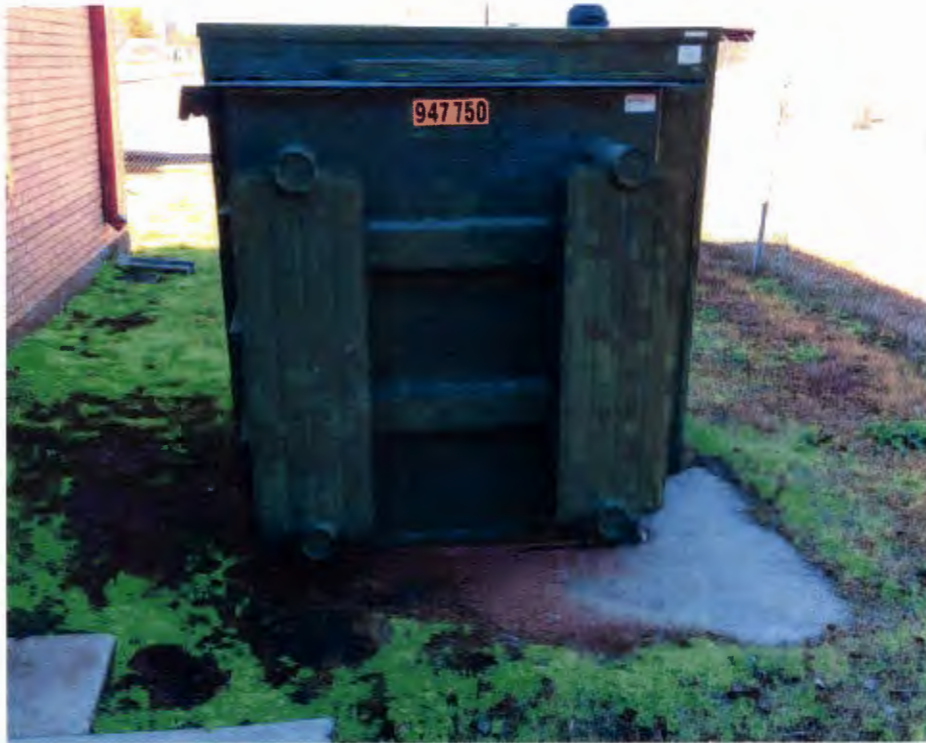
**Photo 11 - PS #15 Utility Transformer**

- At Pump Station #15, the utility transformer is on a concrete pad that appears to be sinking into the soil. It is recommended that the foundation be repaired so that damage does not occur to the transformer or electrical infrastructure of the service entrance conductors. As this transformer is OG&E's equipment, we recommend that the City contact OG&E and inform them of this condition.

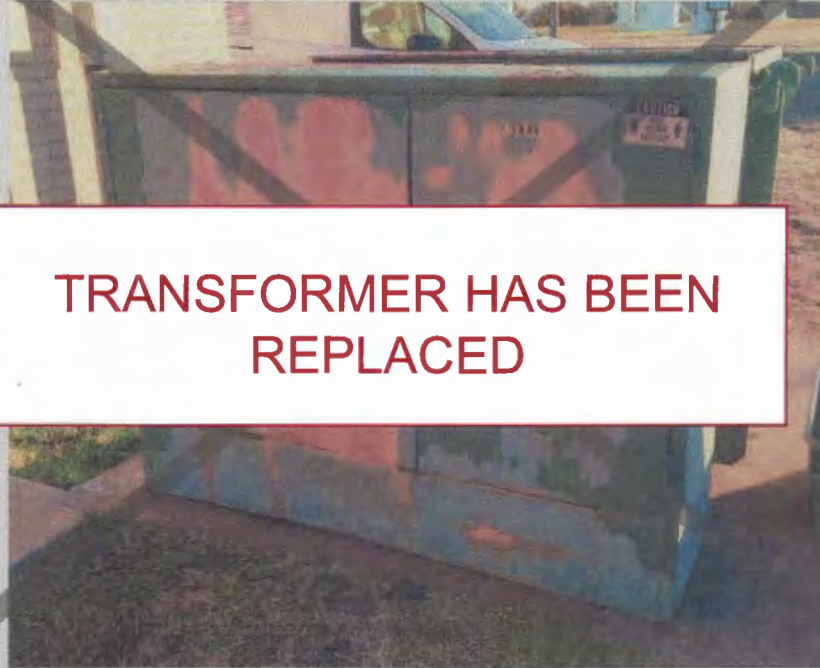
Photo 12 - PS #18 Utility Transformer

At Pump Station #18, the utility service transformer appears to be very old and rusted. Carollo recommends determining if the transformer should be replaced, or repainted depending on the age of the equipment.

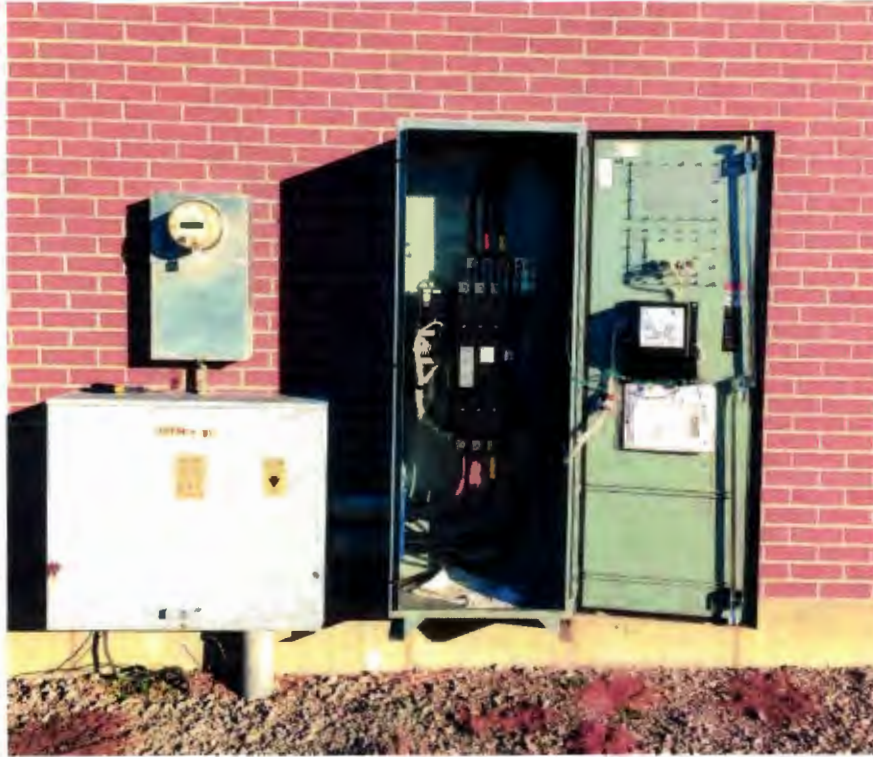
**Photo 13 - PS #19 MTS**

- At Pump Station #19, the utility service enters the facility through a MTS. This switch does not have any overcurrent protection. To comply with NEC 230.91, it is recommended that a service-entrance rated overcurrent protective device be installed between the utility transformer and the MTS.

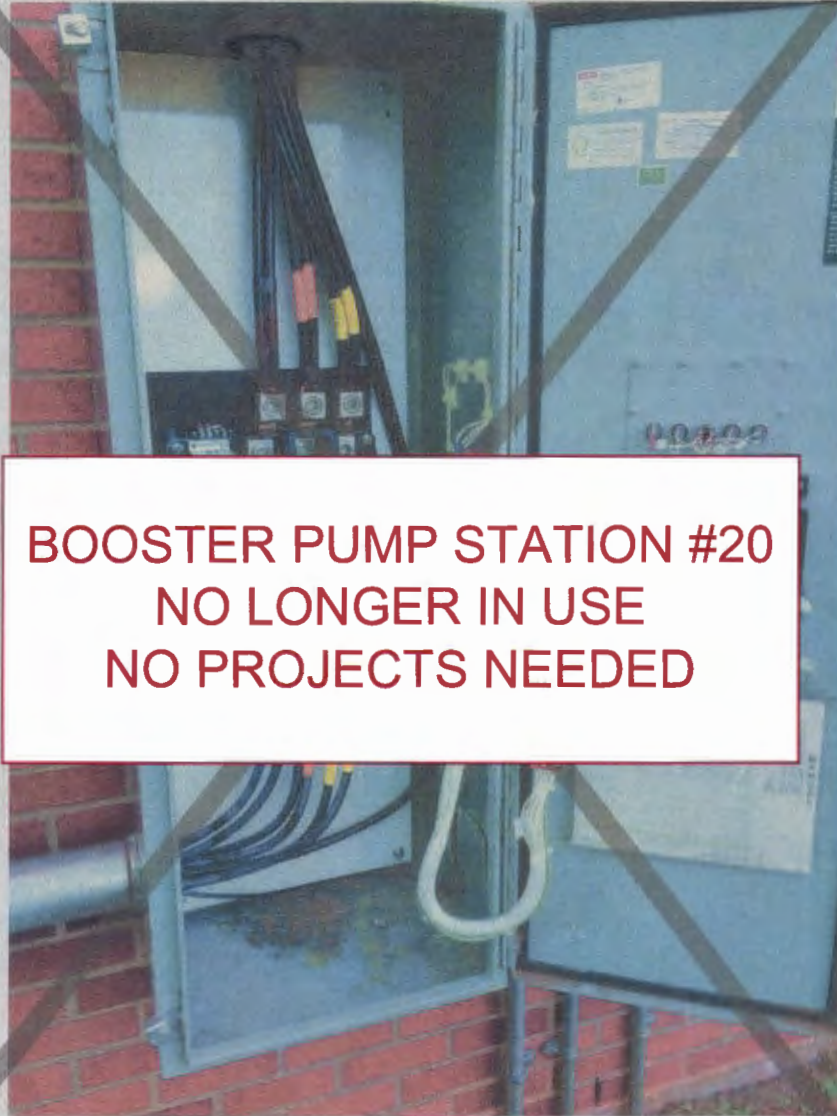
**Photo 14 - PS #20 MTS**

At Pump Station #20, the utility service enters the facility through a MTS. This switch does not have any overcurrent protection. To comply with NEC 230.91, it is recommended that a service-entrance rated overcurrent protective device be installed between the utility transformer and the MTS.

**BOOSTER PUMP STATION #20  
NO LONGER IN USE  
NO PROJECTS NEEDED**

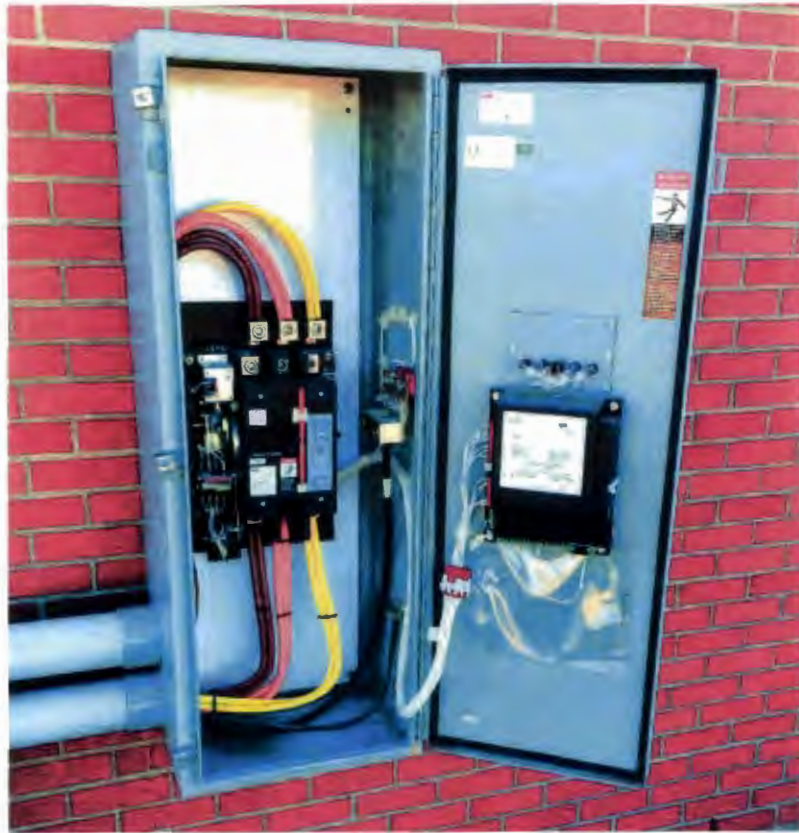
Photo 15 - PS #21 MTS

- At Pump Station #21, the utility service enters the facility through a MTS. This switch does not have any overcurrent protection. Additionally, there is no neutral bonding jumper. To comply with NEC 230.91, it is recommended that a service-entrance rated overcurrent protective device be installed between the utility transformer and the MTS.

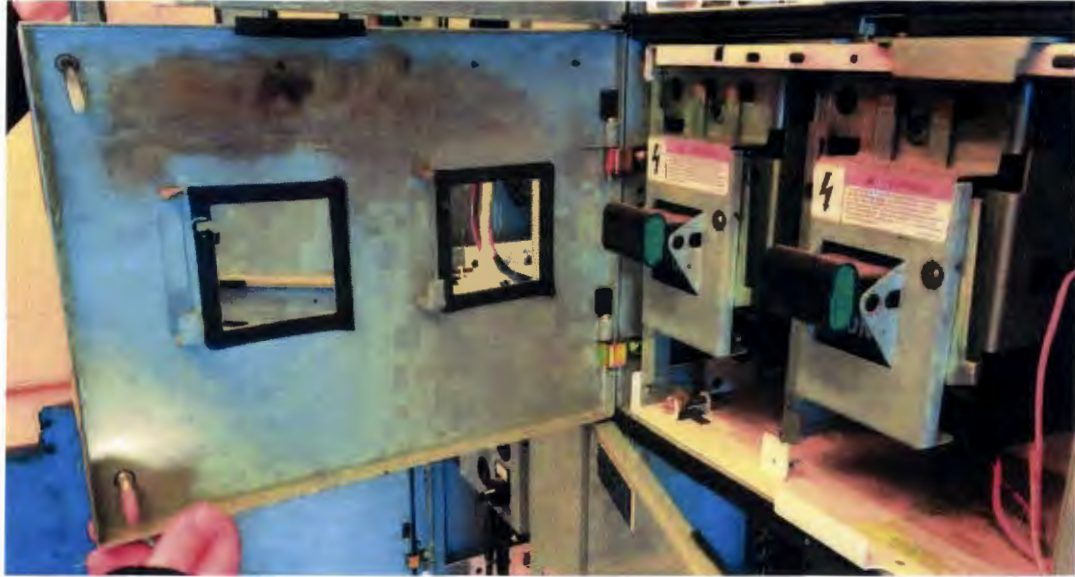
- At Pump Station #21, the MCC is in overall good condition. However, one of the buckets has burn marks on the inside of the door, indicating a fire at some point. Carollo recommends a thorough inspection of the equipment to ensure that it has been repaired accordingly to prevent further issues from arising.

**Photo 16 - PS #21 MCC Bucket with Burn Marks**

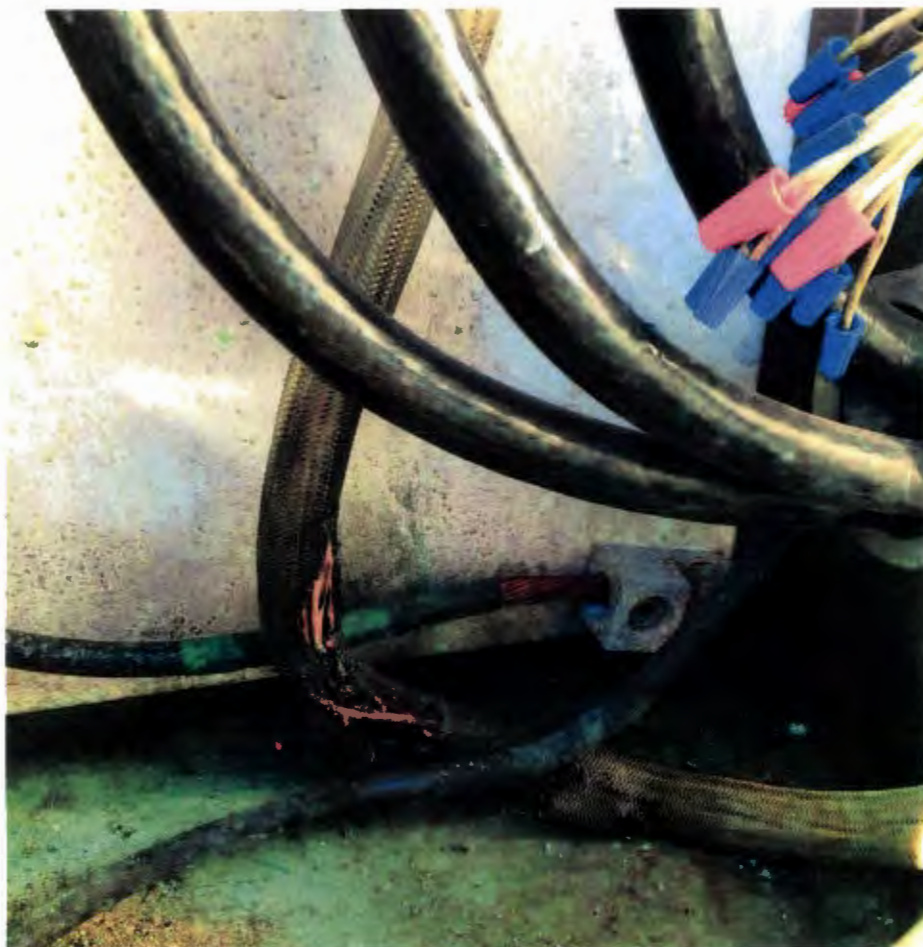
- At Pump Station #23, the MTS has some burn marks inside the enclosure and the control wiring is damaged. This control wiring has been capped with wire nuts, so it is no longer in use. If the City would like the ability to use controls with this switch, the wiring will need to be replaced.

**Photo 17 - PS #23 MTS with Damaged Control Wiring**
