THE CITY OF OKLAHOMA CITY PUBLIC WORKS DEPARTMENT

BRIDGE ASSESSMENT REPORT

NORTH MIDWEST BOULEVARD OVER CRUTCHO CREEK OKLAHOMA CITY, OKLAHOMA

JUNE 2021

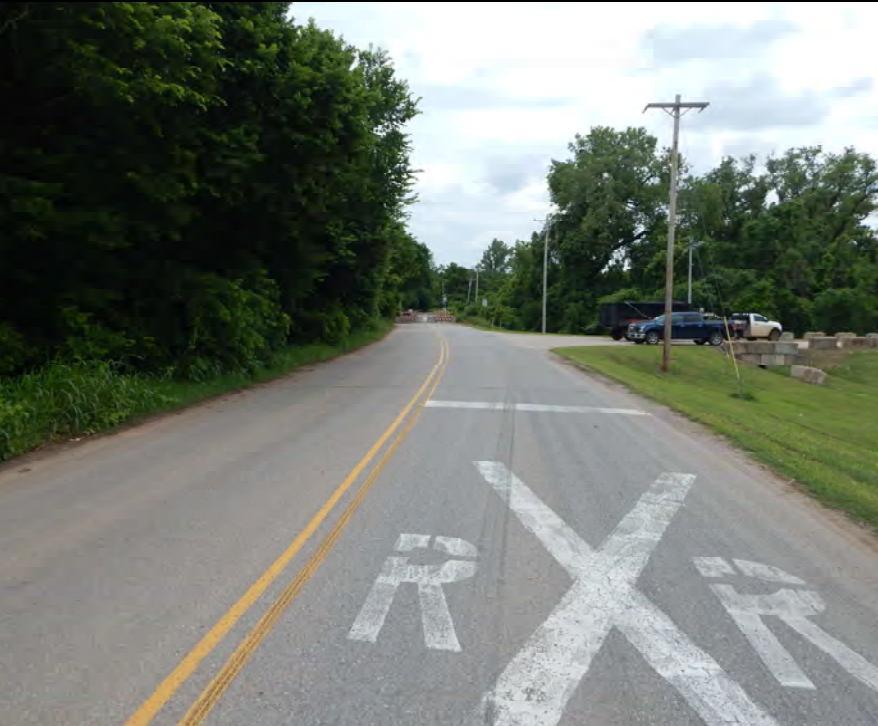
The existing roadway for N. Midwest Blvd. consists of a two lane 24 ft. wide open section with ditches. The existing roadway approaches are asphalt pavement with an unknown pavement thickness. The approach roadway driving surface appears to be in satisfactory condition. No settlement was noted in either approach at the time of the inspection.

Figure 9 – Typical Condition of Approach Pavement (North of Bridge)

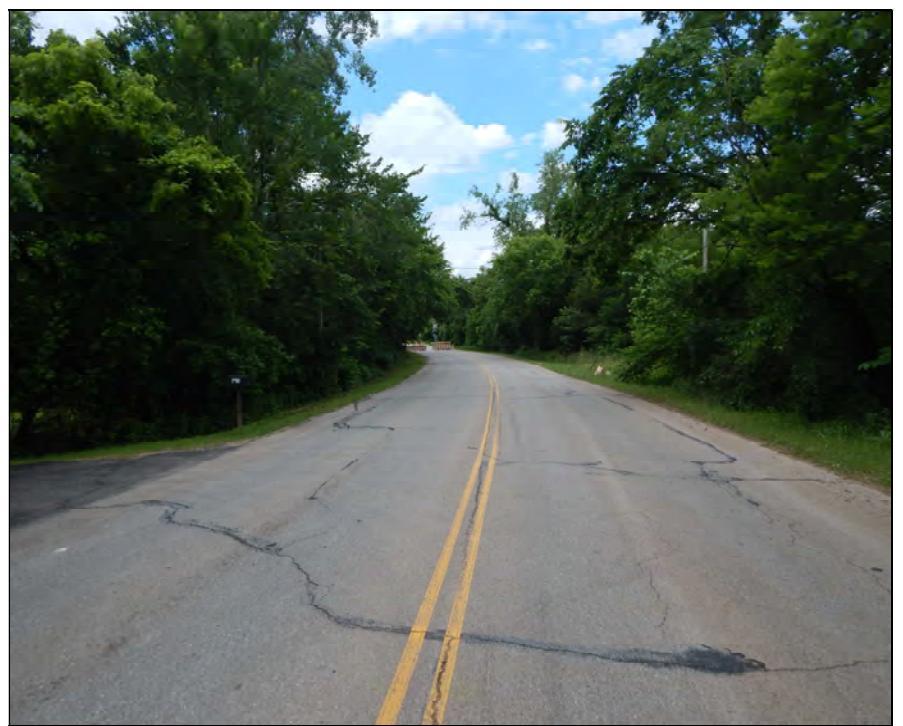
Figure 10 – Typical Condition of Approach Pavement (South of Bridge)

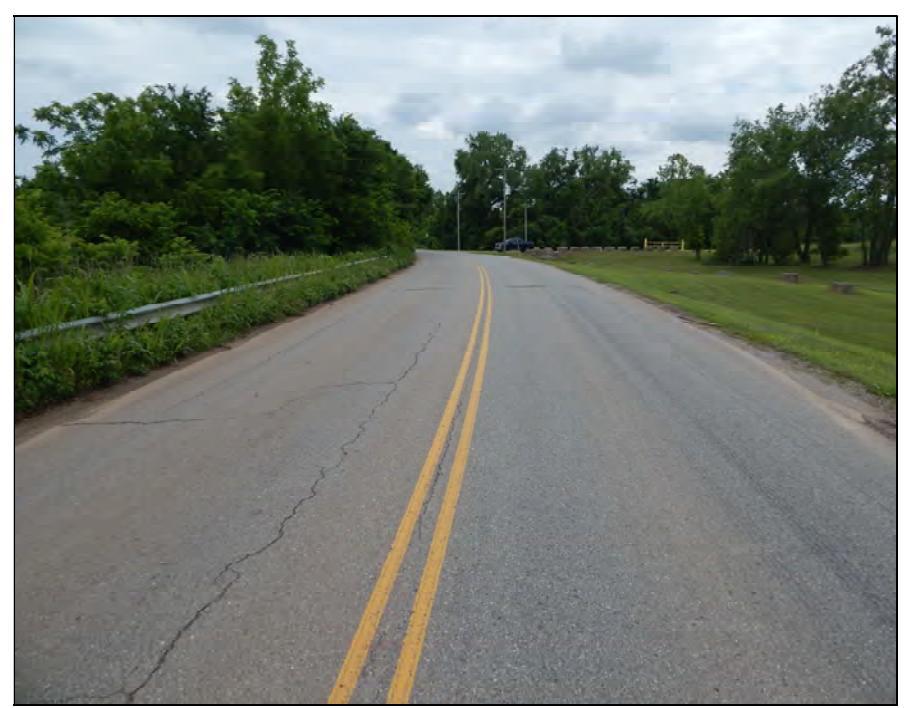
Guardrail is located on both east and west sides of the bridge and approaches and along the east side of N. Midwest Blvd. north of the bridge. The guardrail on the southeast corner of the bridge extends approximately 12 ft. from the bridge and is curved towards the field entrance (Figures 14 and 20). The guardrail on the other corners of the bridge extends approximately 40 ft. from the bridge and terminates with a turn down style end treatment (Figure 15). The guardrail through the extents of the bridge has several areas of major impact damage and has become detached from the east side of the bridge (Figures 16 and 17). All existing guardrail bridge connections, transitions, approach guardrail, and approach guardrail end treatments are substandard. The guardrail along the roadway has minor impact damage and shows signs of age and deterioration (Figures 12, 18, and 19).

Figure 12 – Approach Roadway Line of Sight Looking South (Approximately 350 ft. North of Bridge)

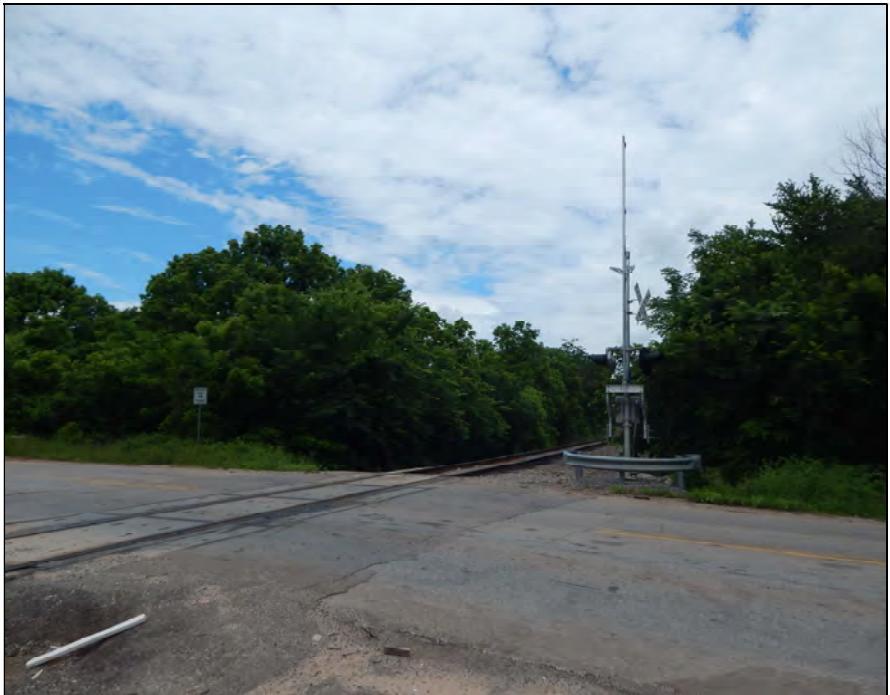
Figure 13 – Condition of At-Grade Railroad Crossing

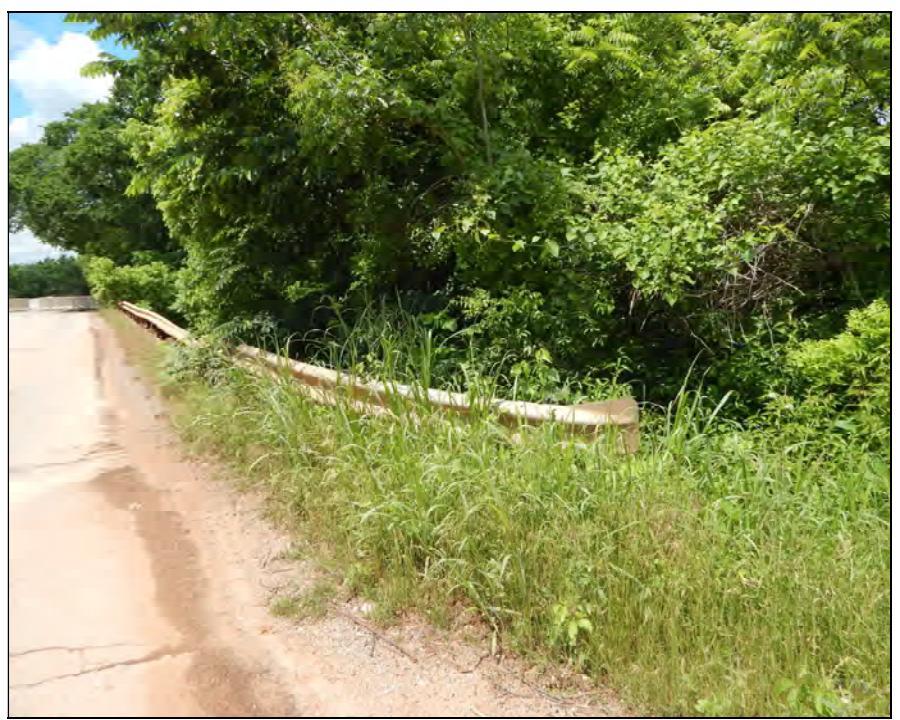
Figure 14 – Bridge Approach Guardrail at Southeast Corner of Bridge

The guardrail located along the bridge approaches will be removed and replaced with a new guardrail system including asphalt guardrail widening. The guardrail at both approaches will include a connection to the new bridge concrete rail and a modified guardrail length at each end of the bridge approaches. The guardrail south of the bridge will be modified to accommodate the railroad and the property entrance at the southeast corner of the bridge. The guardrail north of the bridge on the east side can be extended approximately 100 ft. with a GET and w-beam single guardrail, however, the guardrail on the west side of N. Midwest Blvd. will terminate south of the existing commercial drive and will be modified to accommodate the drive entrance.

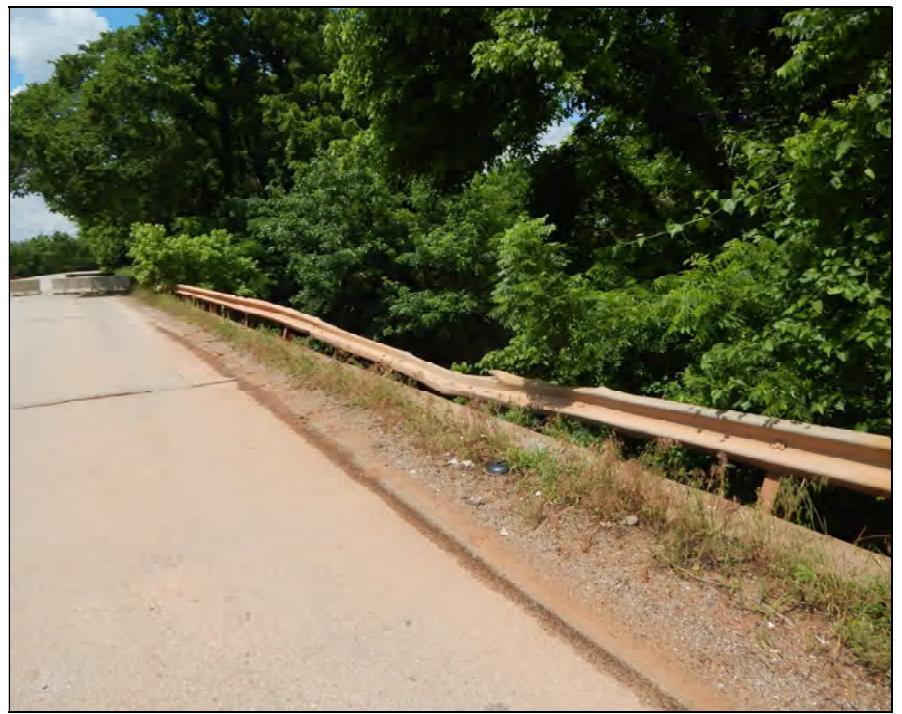
Figure 16 – Typical Condition of Guardrail along East Side of Bridge

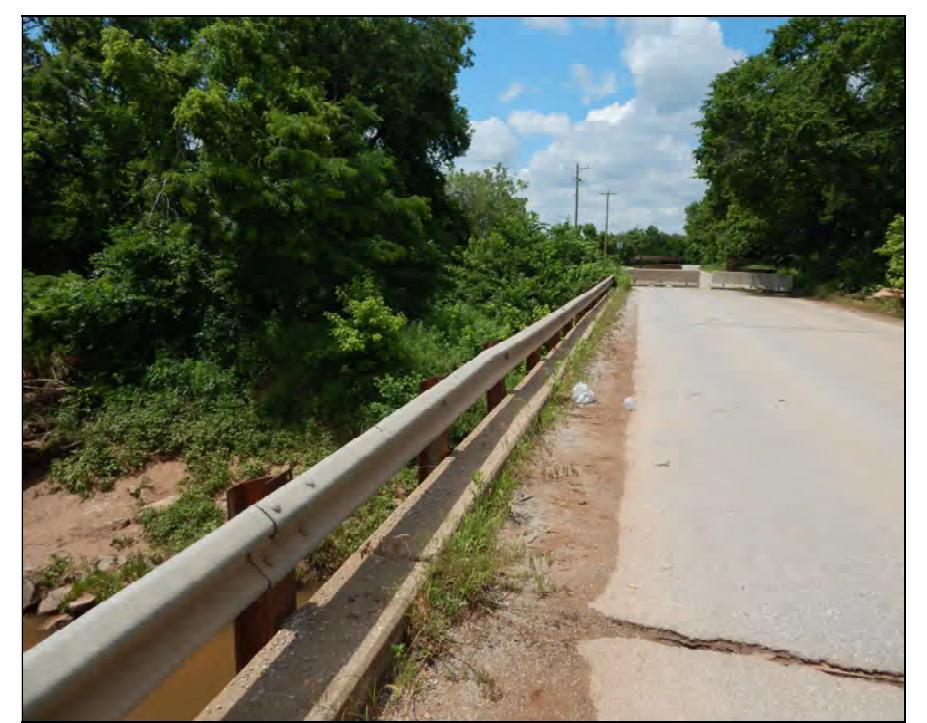
Figure 17 – Typical Condition of Guardrail along West Side of Bridge

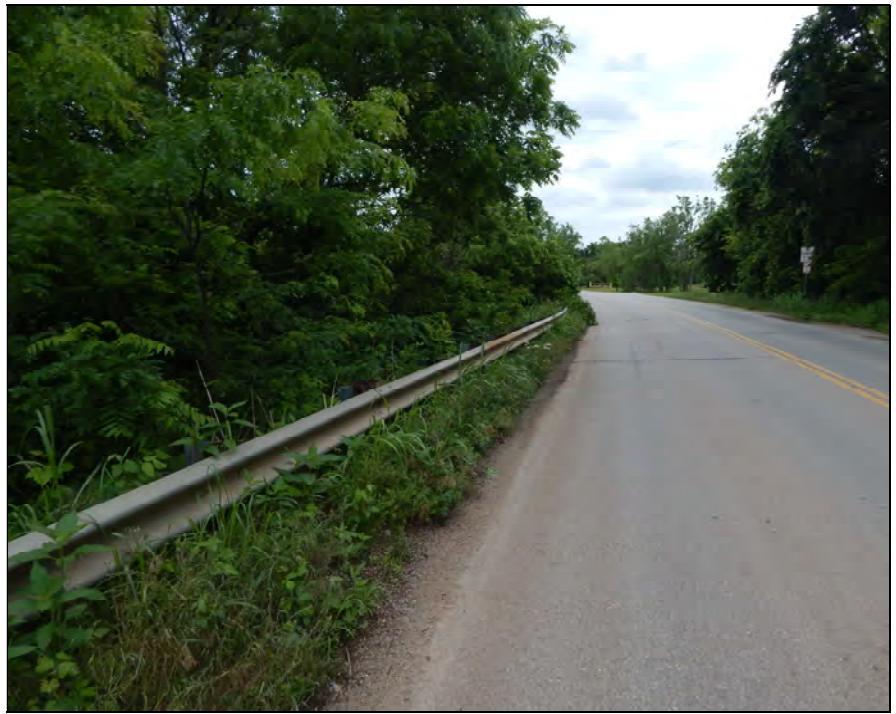
Figure 18 – Typical Condition of Guardrail along Roadway (North of Bridge)

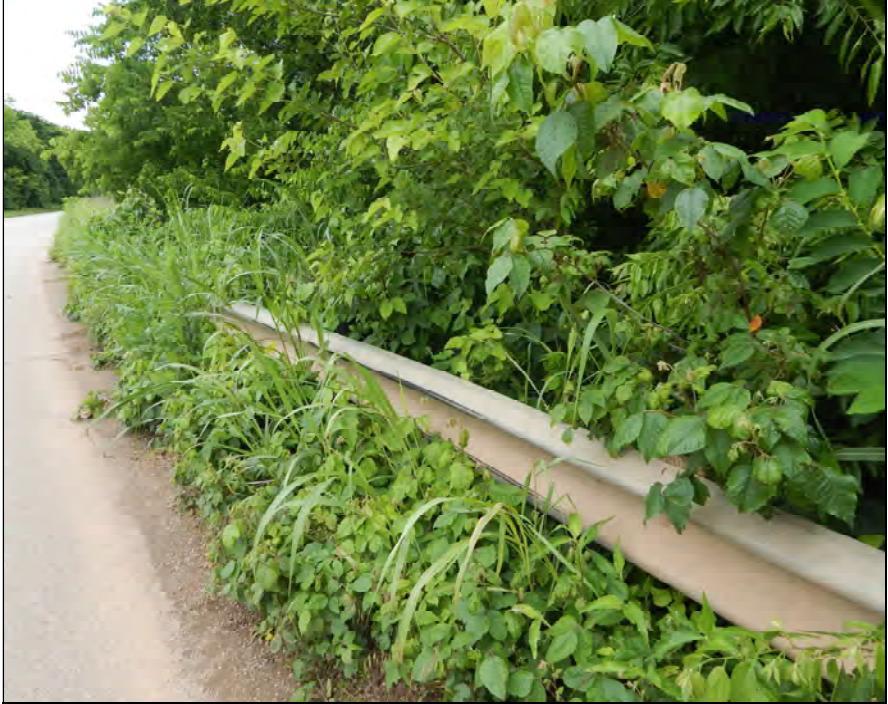
Figure 19 – Impact Damage to Guardrail along Roadway

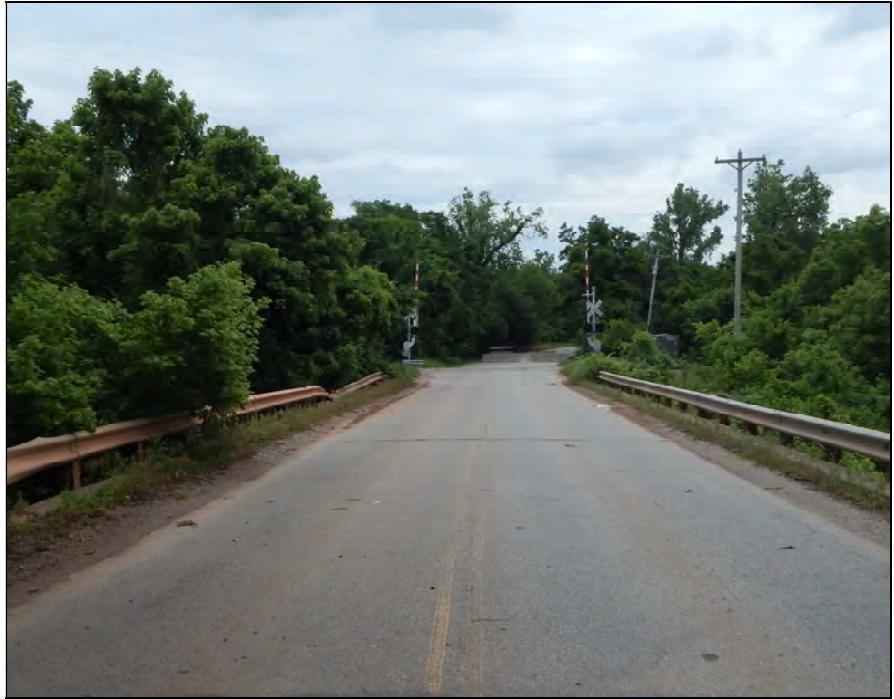
Per the 2019 Bridge Inspection Report, a 2 inch thick asphalt overlay wearing surface was placed on the bridge deck in 1991. The bridge deck driving surface has isolated longitudinal and transverse cracks in the asphalt overlay. Spalling of the asphalt wearing surface was observed along the joints above each pier.

Figure 21 – Typical Deck Driving Surface Condition

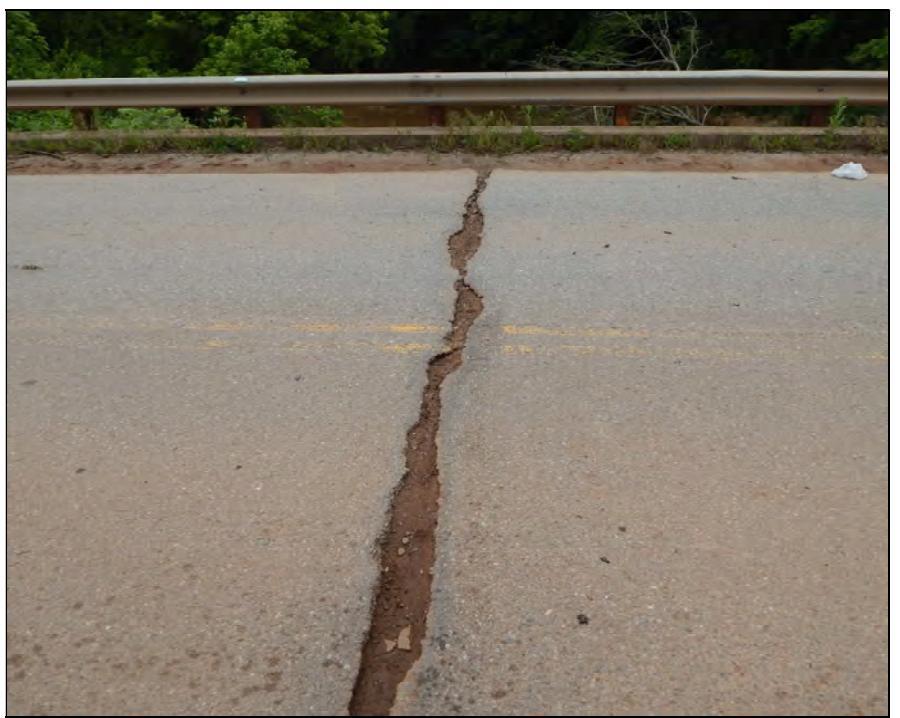
The joints above each pier have failed and allow water to drip onto the structure below.

Figure 22 – Typical Joint above Piers

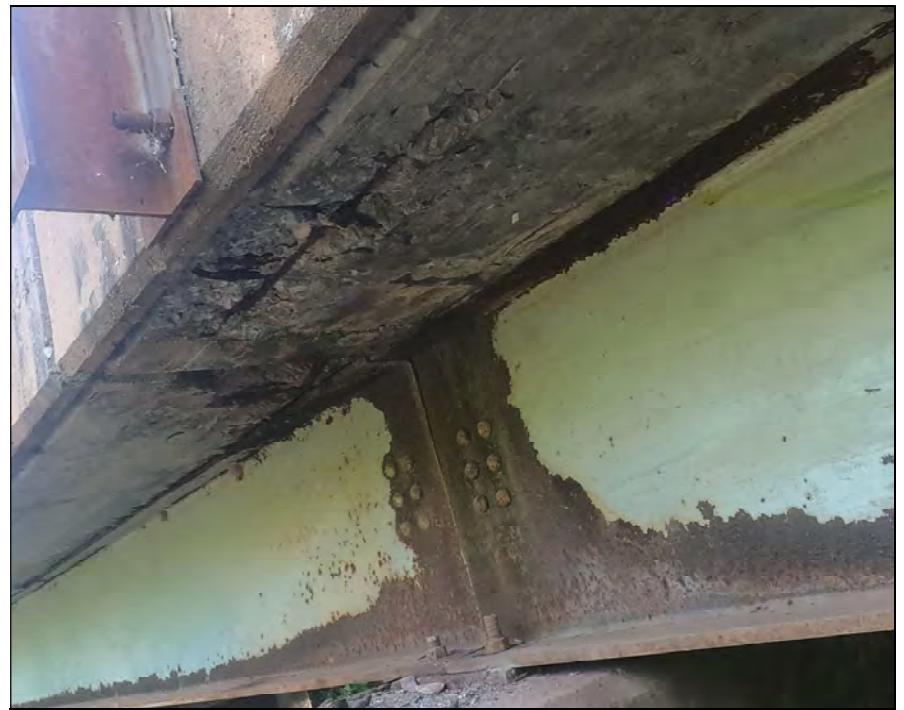
The bridge deck soffit is generally in good condition, but is showing signs of delamination, corrosion staining, and spalling with exposed reinforcing steel at the overhangs and bays along the joints above each pier. The typical deck soffit deterioration extends approximately 3 ft. on each side of the joints above each pier. Concrete cracking was observed at the deck haunch above each pier diaphragm. At the time of the inspection, it appeared that the deck has separated from the top of the beams that have buckled at each pier. Hairline cracks were observed throughout the deck soffit between each bay.

Figure 23 – Typical Condition of Deck Overhang Soffit at Pier 1

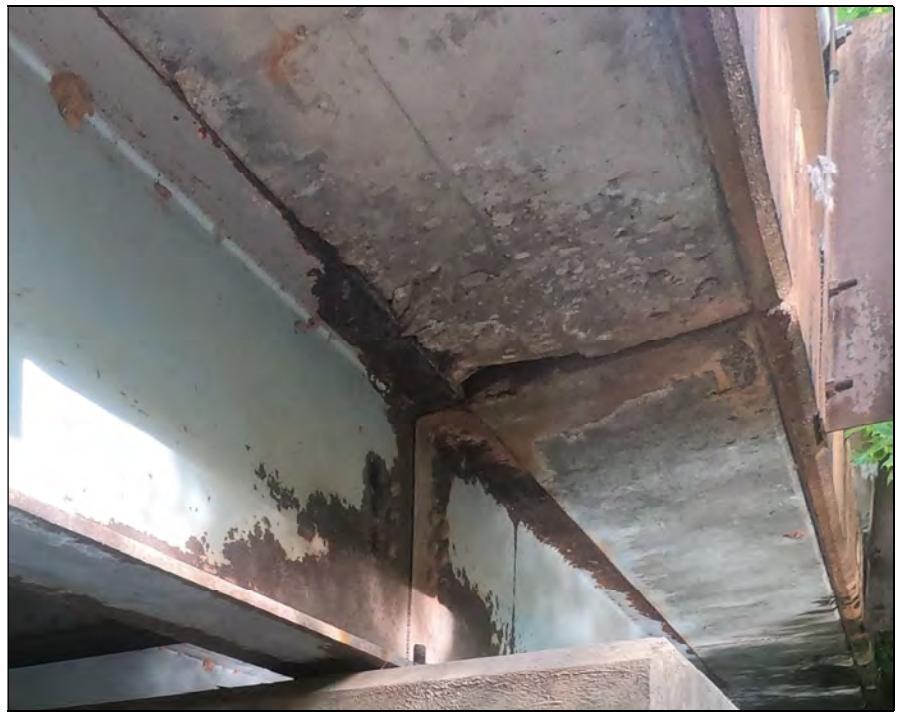
Figure 24 – Typical Condition of Deck Overhang Soffit at Pier 2

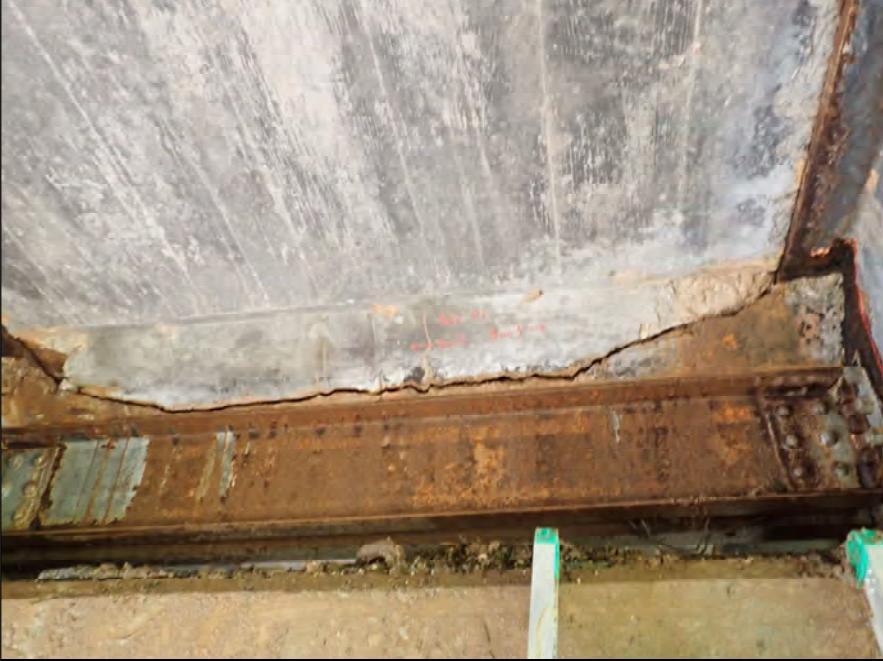
Figure 25 – Typical Concrete Cracking of Deck Haunch above Pier Diaphragms

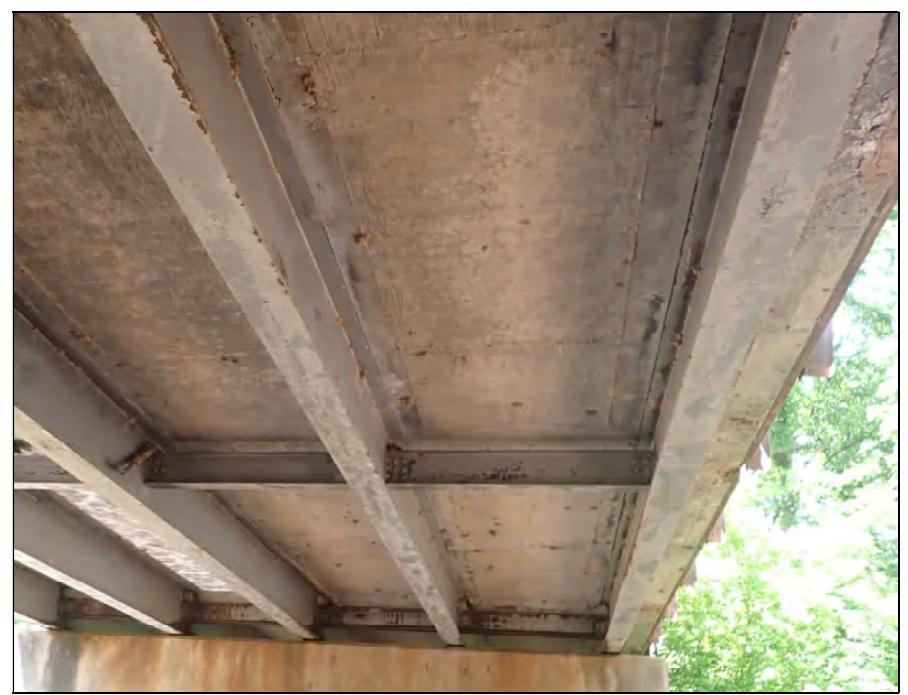
Figure 26 – Typical Condition of Deck Soffit

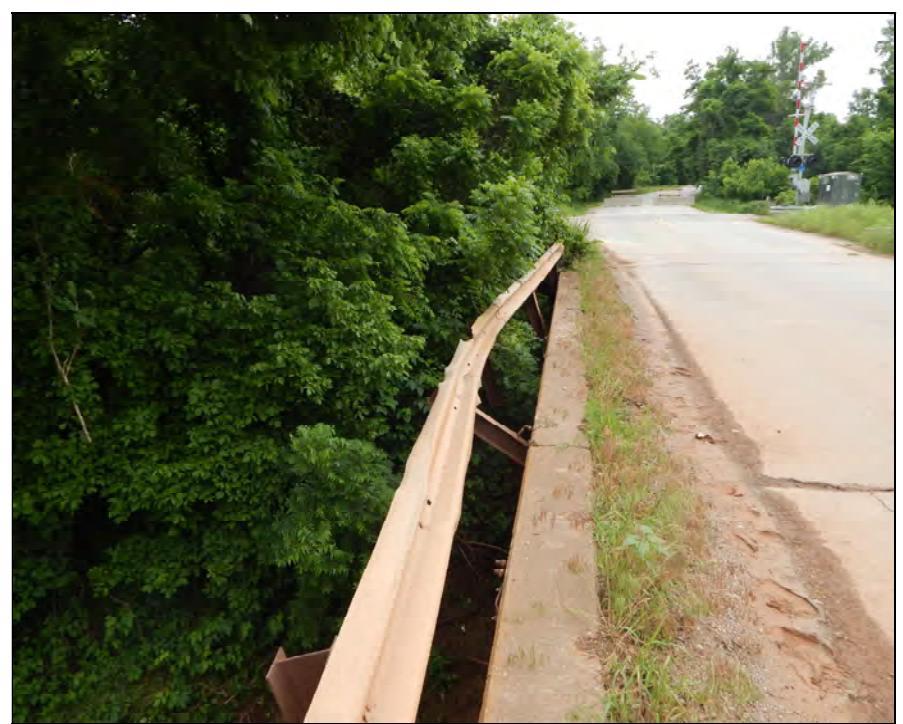
The existing guardrail is showing signs of major impact damage primarily on the east side of the bridge. Several guardrail posts have detached from the side of the bridge deck due to vehicular impact.

Figure 27 – Guardrail Impact Damage on East Side of Bridge

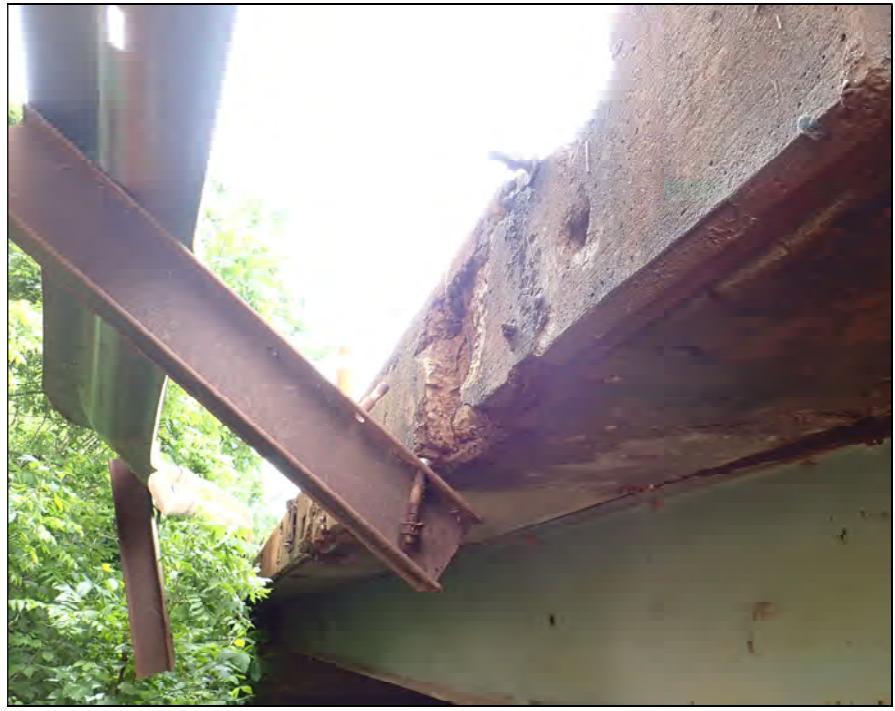
Figure 28 – Detached Guardrail Posts on East Side of Bridge

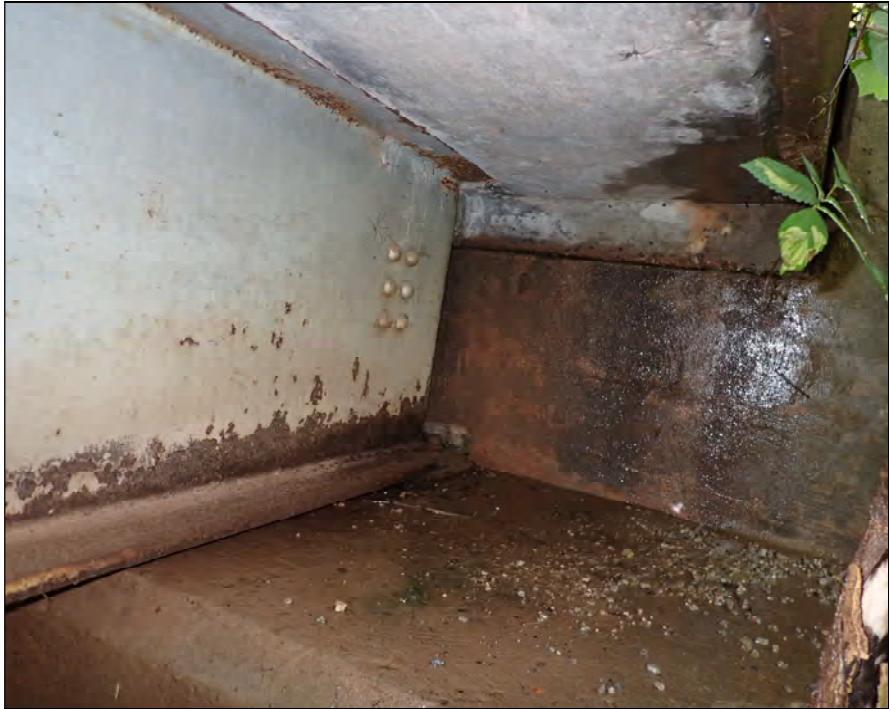
The existing bridge superstructure consists of three simply-supported rolled steel beam spans. The beams appear to be in poor condition with moderate to heavy corrosion, severe section loss of the webs, web buckling and visible sagging. Areas of moderate to heavy corrosion and steel section loss were observed on the diaphragms and connections above the piers. Light to moderate surface rust was observed on the diaphragms and connections at the abutments and on the intermediate diaphragms. The ends of the beams at the abutments exhibit light to moderate corrosion. Section loss of the beam end web was observed on Beams 4 and 5 at Abutment 2 (Figure 30). The ends of the beams at the piers exhibit moderate to heavy corrosion with severe section loss of the webs and web buckling of the interior beams (Figures 31 - 37). The protective coating of paint on the beams, diaphragms, and bearing assemblies appears to be in poor condition. Several beam ends above the piers were observed to be in contact (Figure 37).

Figure 29 – Typical Beam End Condition at Abutments

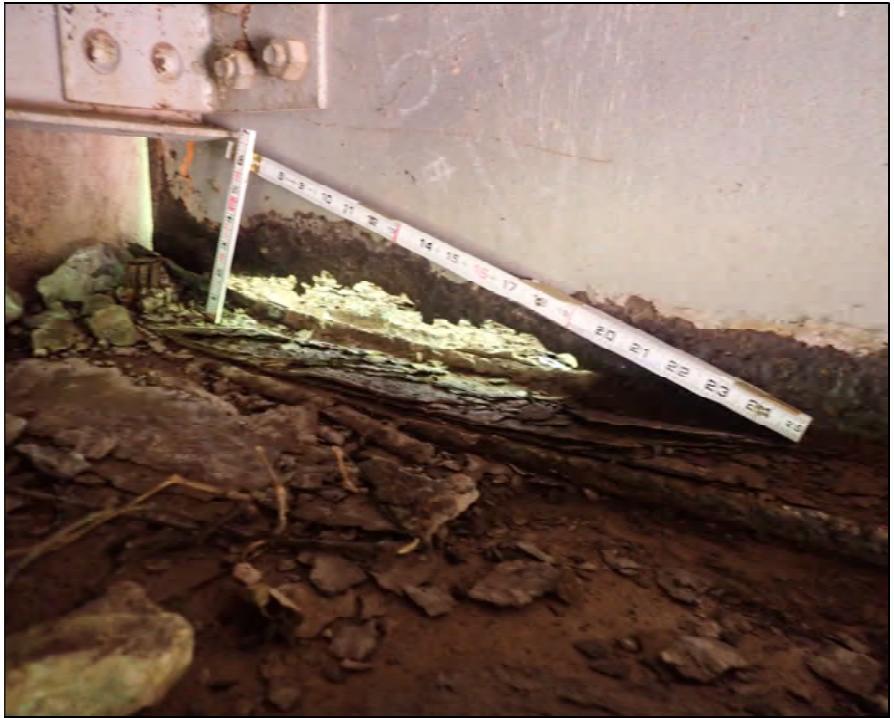
Figure 30 – Beam Web Section Loss (Abutment 2, Beam 5)

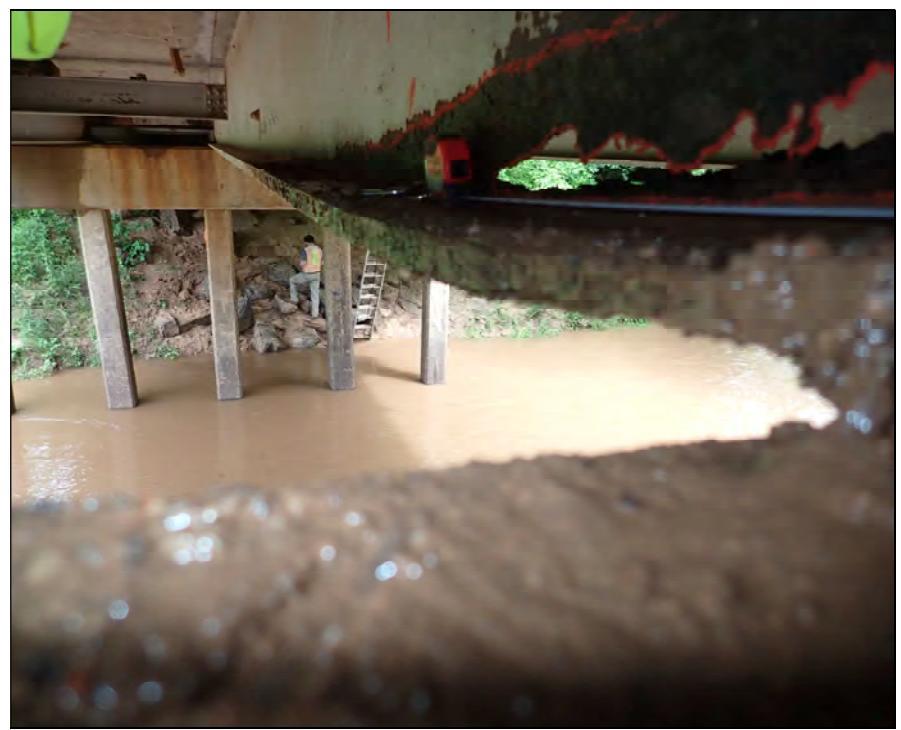
Figure 31 – Web Section Loss with Distortion of Bottom Flange

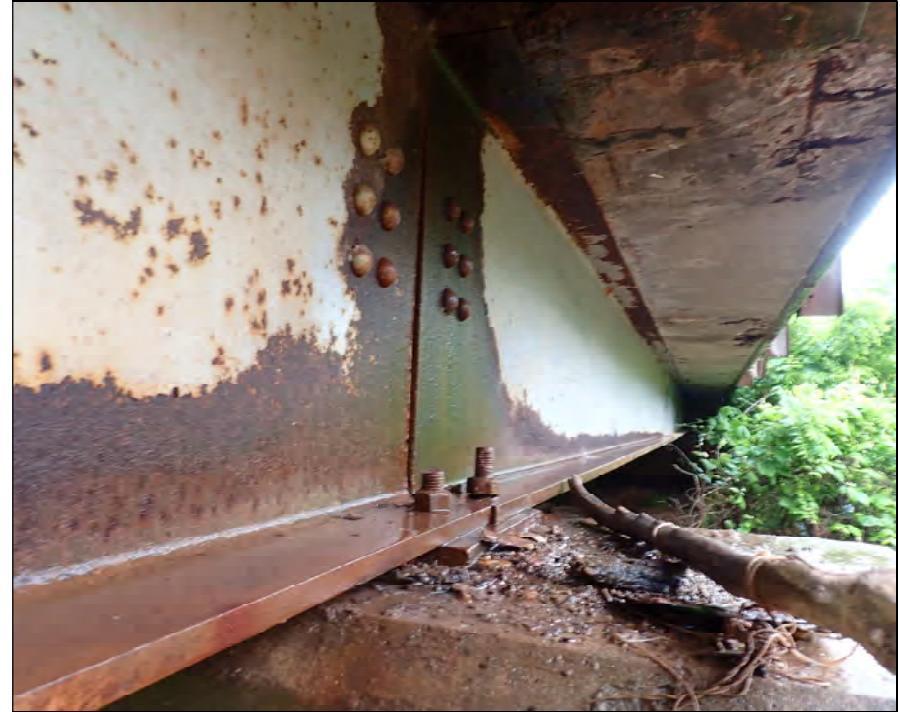
Figure 32 – Condition of Exterior Beams at Pier 1

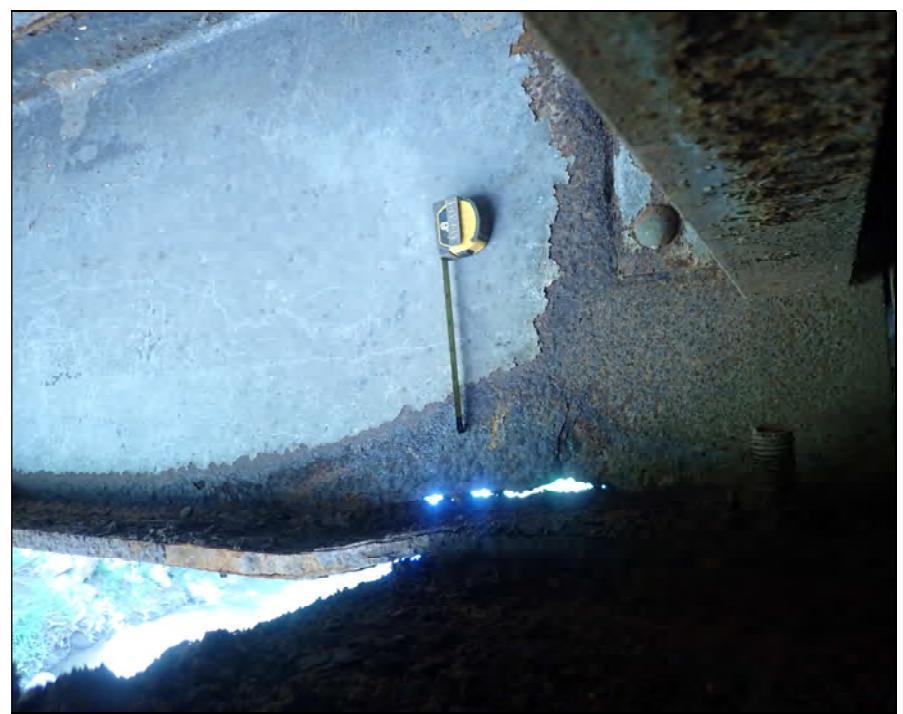
Figure 33 – Web Section Loss with Distortion of Bottom Flange

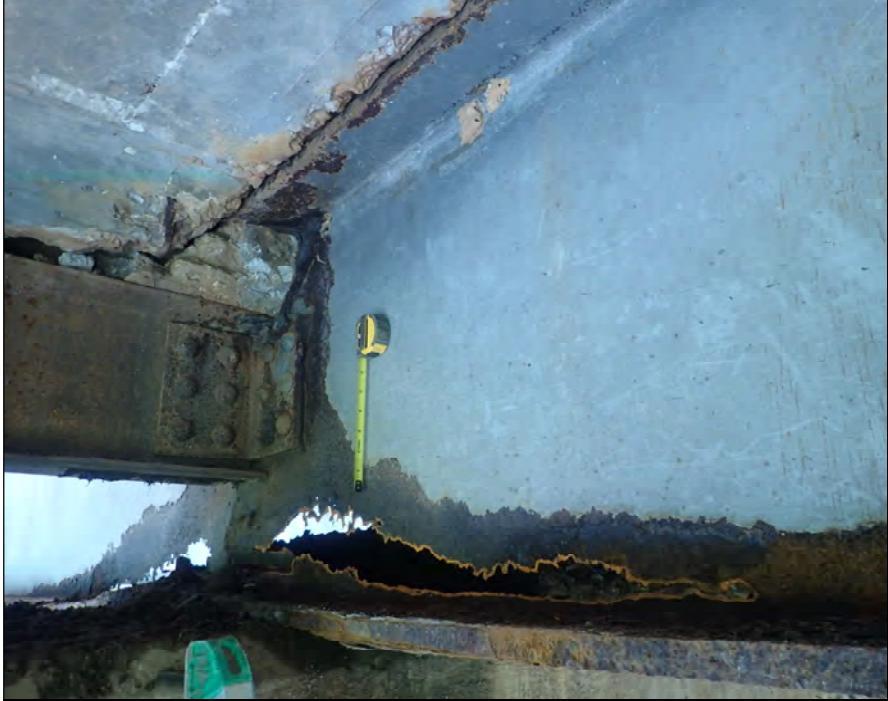
Figure 34 – Web Section Loss and Web Buckling with Distortion of Bottom Flange

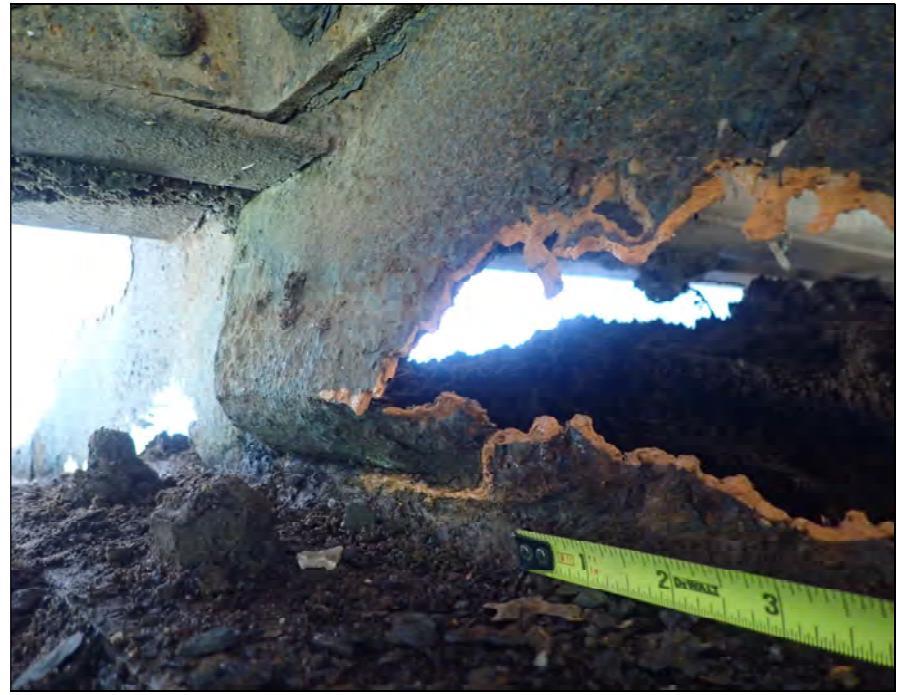
Figure 35 – Web Section Loss and Web Buckling

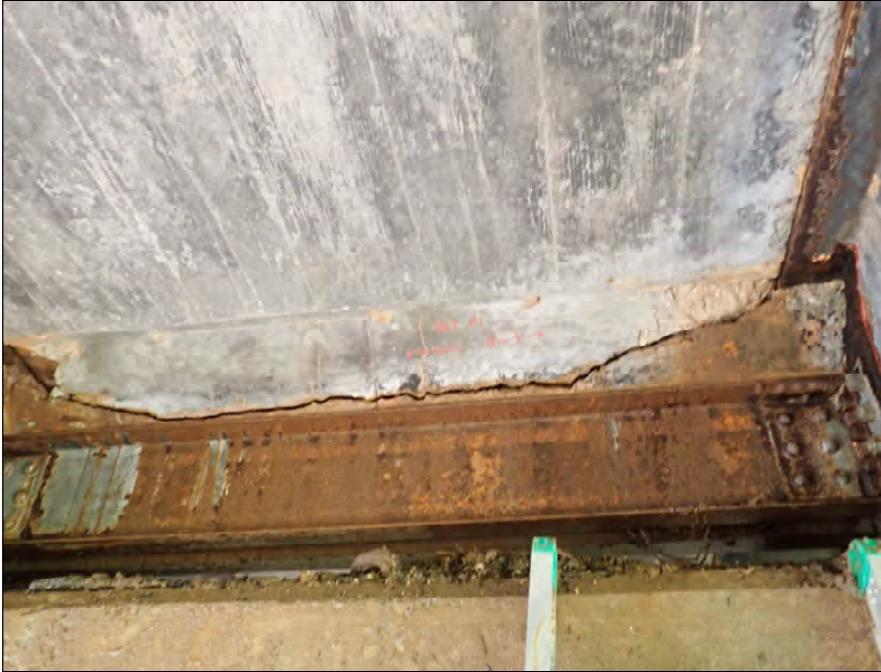
Figure 36 – Typical Condition of Diaphragms above Piers

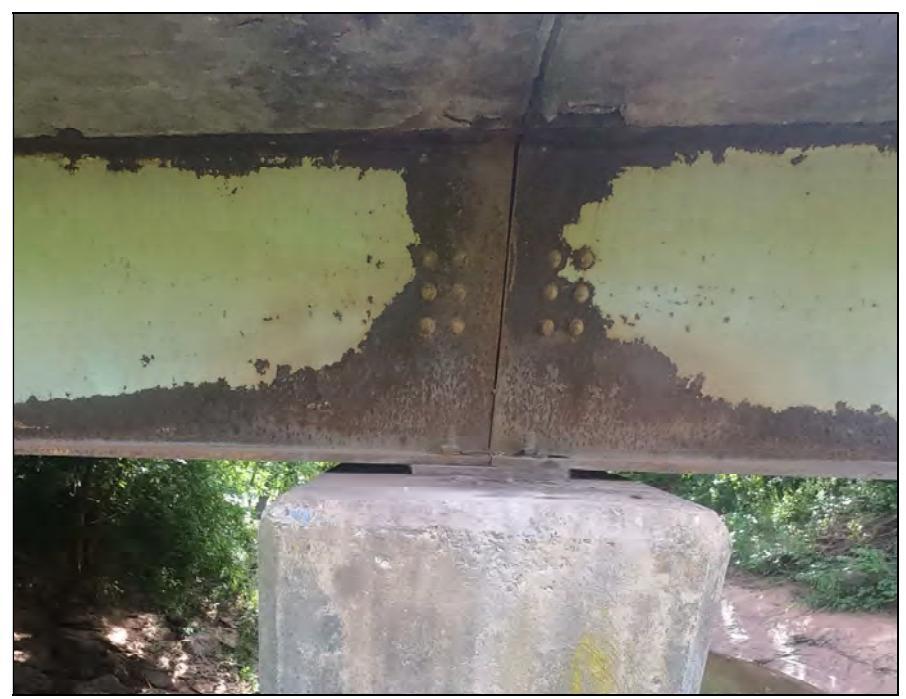
Figure 37 – Typical Beam Spacing Between Spans at Piers

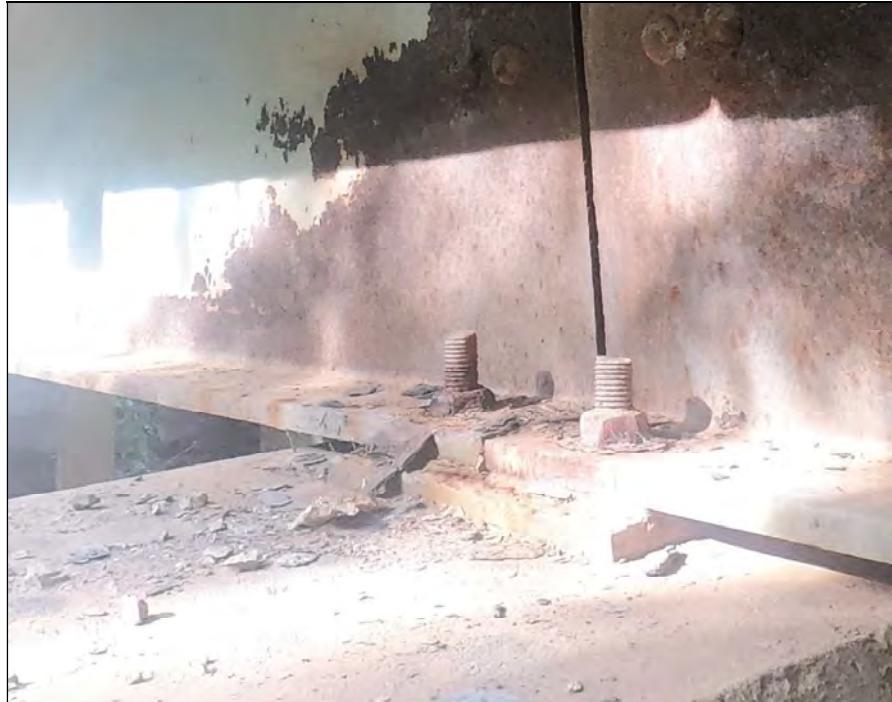
Figure 38 – Typical Condition of Bearing Assembly

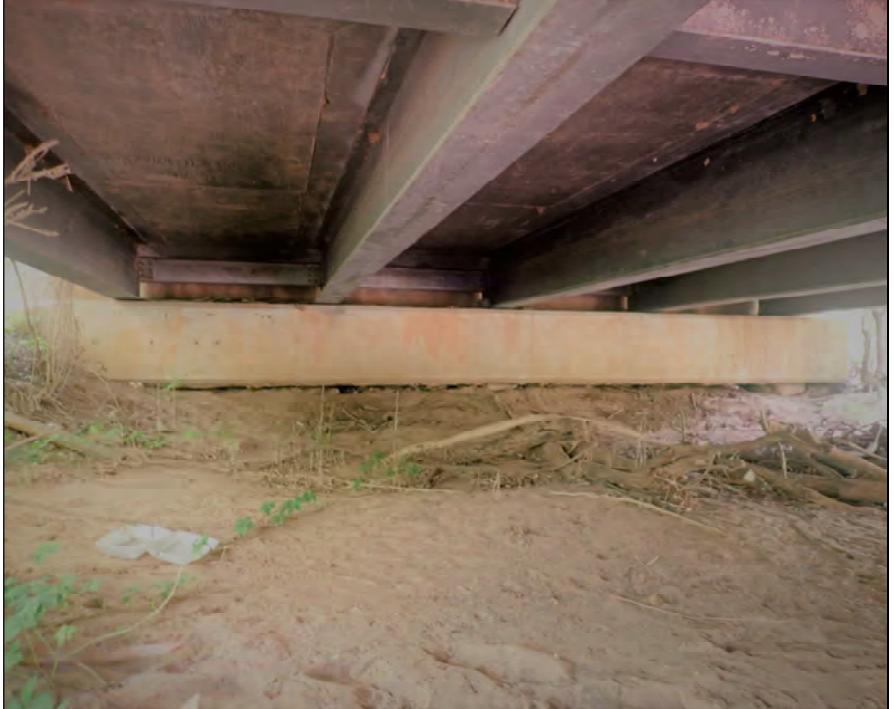
The abutments consist of reinforced concrete seats with concrete pile foundations. The abutments are in satisfactory condition with isolated areas of concrete delamination and cracking on the abutment seats and backwalls. Undermining of the abutment seat with exposed concrete piles was observed at the both abutments.

Figure 39 – Typical Condition of Abutment Seats

All spalled or delaminated concrete at the abutments and piers will be repaired with pneumatically placed mortar or class AA concrete, if necessary. Corrosion inhibitor will be applied to the repaired areas on the substructure. Urethane coating surface treatment, CIM 1000 or approved equivalent, will be applied to the top of the abutment seats and pier caps, 6 inches down from the top of the bridge seat and pier cap, and along the entire abutment backwall. Concrete cracking of the substructure will be repaired with epoxy injection. The bridge header slope will be excavated down approximately 2 ft. to allow access under the bridge seats. The exposed abutment piles will be encased in CLSM. The abutment headers will be reshaped. Rip-rap will be placed around the abutment headers through the extents of the bridge.

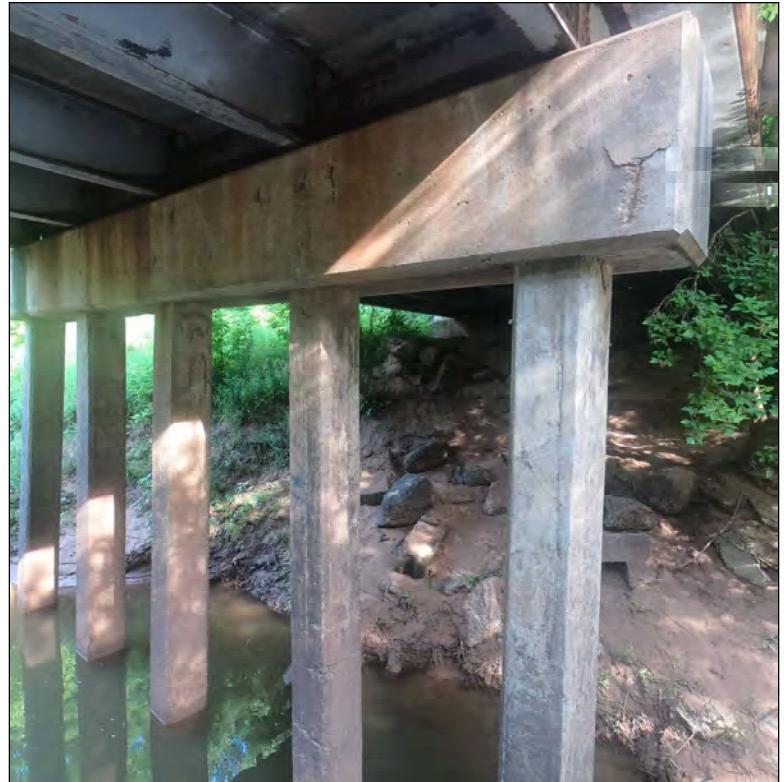
The piers consist of reinforced concrete pier caps with concrete pile foundations. The pier caps and piles are in satisfactory condition with isolated areas of concrete delamination, concrete spalling with exposed reinforcing steel, and isolated areas of vertical cracking on the pier caps.

Figure 42 – Typical Condition of Pier 2

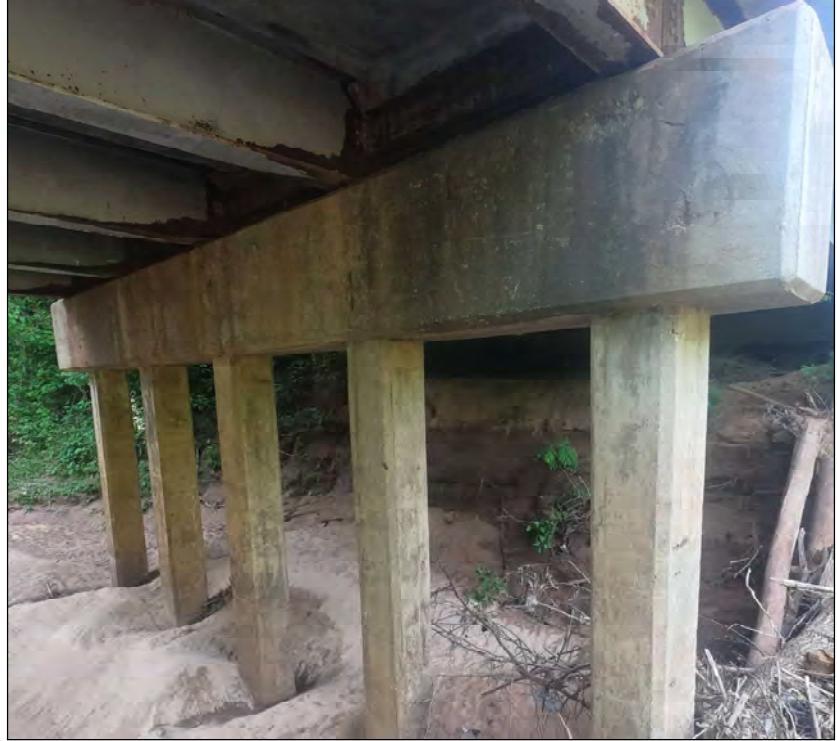
Figure 43 – Typical Condition of Pier 1

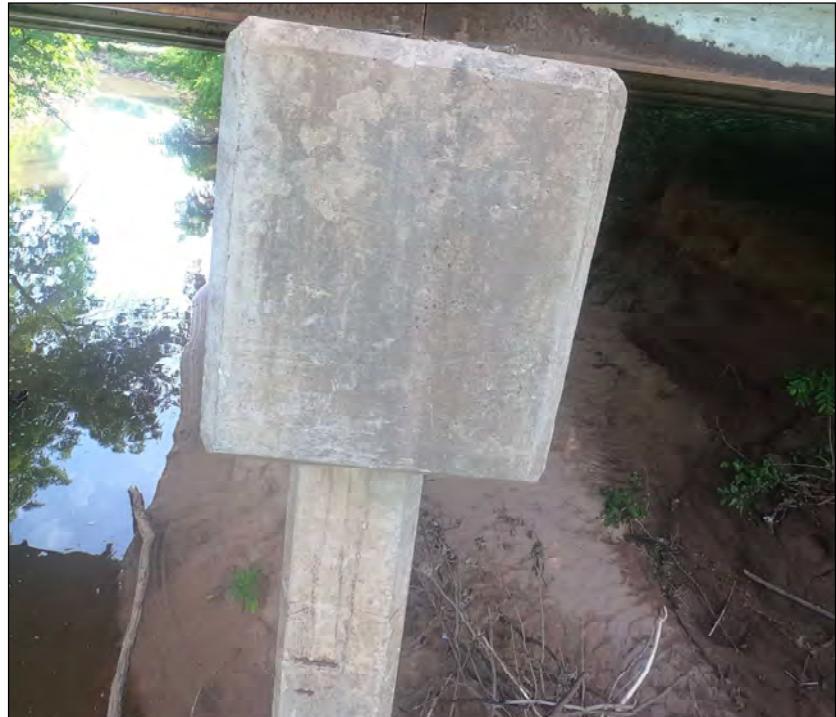
Figure 44 – Typical Condition of Pier Cap End

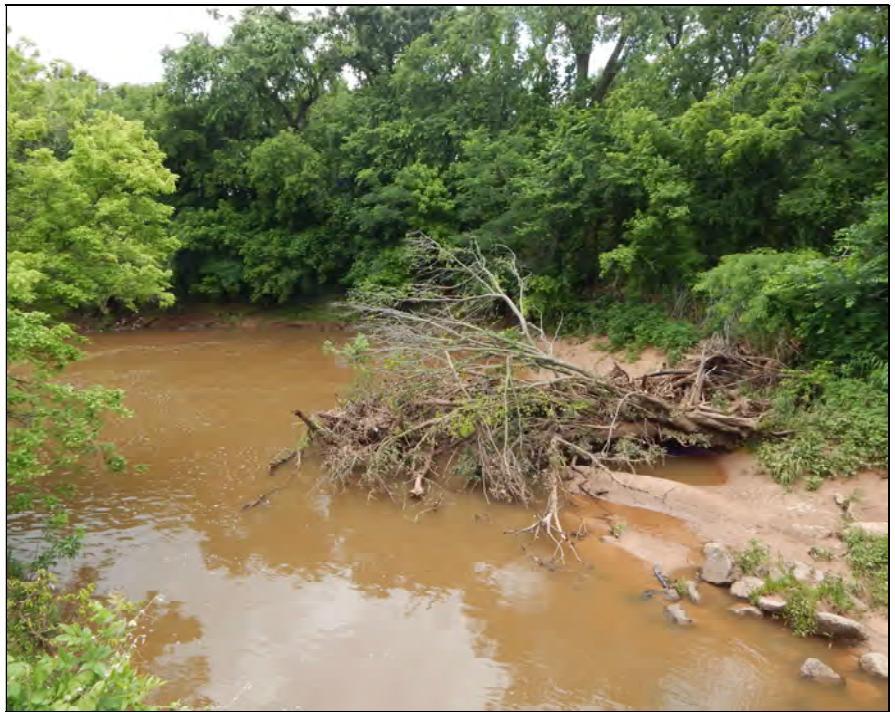
Figure 46 – Channel Debris at West Side of Bridge
