THE CITY OF OKLAHOMA CITY PUBLIC WORKS DEPARTMENT

BRIDGE ASSESSMENT REPORT

NORTH MIDWEST BOULEVARD OVER CRUTCHO CREEK OKLAHOMA CITY, OKLAHOMA

JUNE 2021

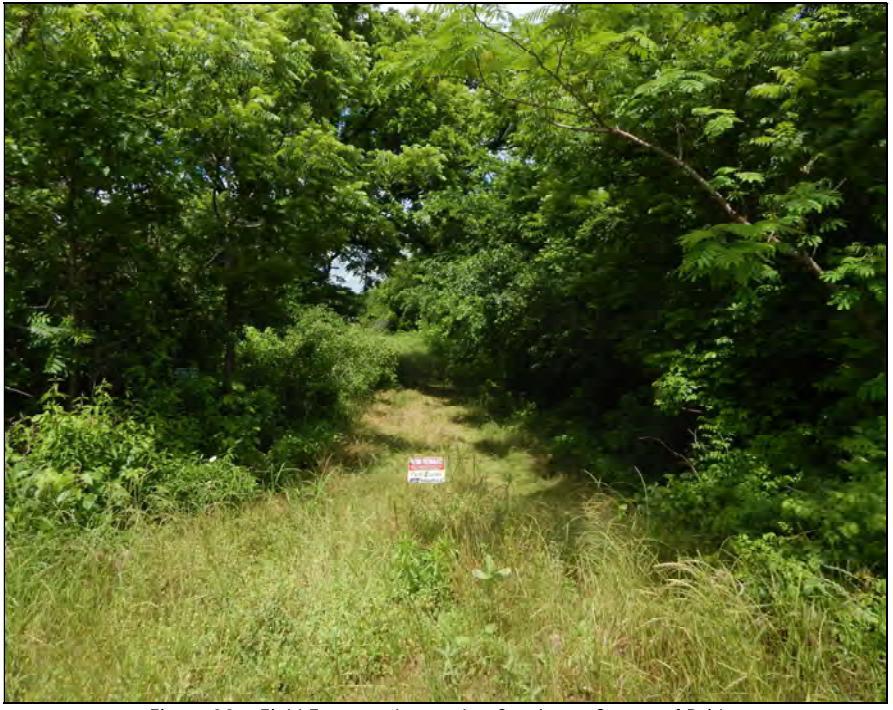
Figure 20 – Field Entrance Located at Southeast Corner of Bridge

Guardrail is located on both east and west sides of the bridge and approaches and along the east side of N. Midwest Blvd. north of the bridge. The guardrail on the southeast corner of the bridge extends approximately 12 ft. from the bridge and is curved towards the field entrance (Figures 14 and 20). The guardrail on the other corners of the bridge extends approximately 40 ft. from the bridge and terminates with a turn down style end treatment (Figure 15). The guardrail through the extents of the bridge has several areas of major impact damage and has become detached from the east side of the bridge (Figures 16 and 17). All existing guardrail bridge connections, transitions, approach guardrail, and approach guardrail end treatments are substandard. The guardrail along the roadway has minor impact damage and shows signs of age and deterioration (Figures 12, 18, and 19).
