**OKLAHOMA CITY FIRE DEPARTMENT  
FIRE PREVENTION SERVICES  
FIRE INVESTIGATION UNIT**

**ORIGIN AND CAUSE REPORT WRITTEN BY FIRE INVESTIGATOR J. HOFFMAN:**

**OKC Fire Suppression Incident Number (ERS#): 2022-10149**

**Incident Address:** 6161 N Western Ave.  
Oklahoma City, OK 73118

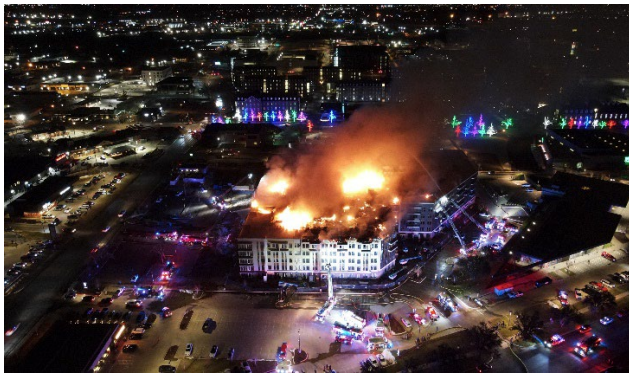
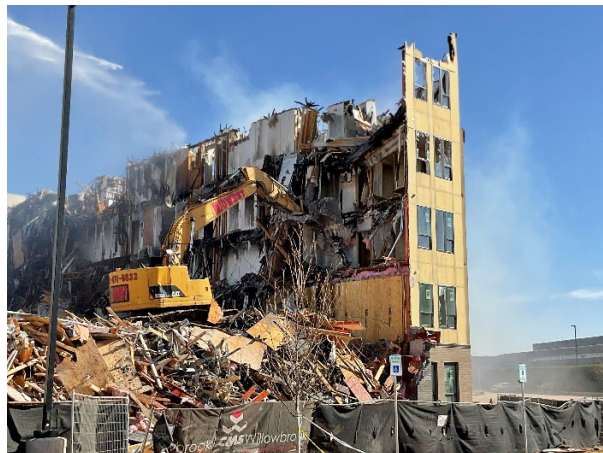
Oklahoma City Fire Investigators Major Chris Hoffman, Major Chad Adams, and Major William Hunt responded and was briefed by the Incident Commander, (602-A) Battalion Chief Kyle Durham. Initial exterior photographs were taken by the fire investigators at approximately 2000 hours. Fire investigators were not able to look at the interior of the structure as OKCFD Operations encountered a rapidly growing fire in inaccessible areas. The incident commander rendered the structure as not tenable and unsafe to enter. On February 9, 2022, Fire investigators Major Ronnie Barbee & Major Mark Davis arrived on scene. They contacted Special Agent Chad Oubre with the Bureau of Alcohol, Tobacco, Firearms and Explosives (ATF) to ascertain if the ATF National Response Team (NRT) could be utilized for the origin and cause determination. Special Agent Oubre called for the NRT. Shortly after, the incident commander ordered the construction company (CMS Willowbrook) to demolish the structure. This decision caused the cancellation of the NRT. No deaths or serious injuries were reported as a result of this fire.
