LOI SUPPORTING DOCUMENTATION FOR WC-1039

EXCERPT FROM WY-0002/SY-0003 REPORT  
*ARC FLASH SUMMARY & FIELD INVESTIGATION EVALUATION*

## 5.0 FIELD INVESTIGATION EVALUATION

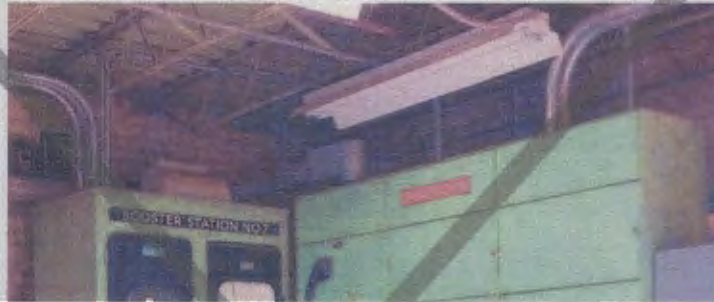
Photo 1 - MTS Nameplate

At Pump Station #7, the electrical distribution gear is very old and is scheduled to be replaced within 1 year. The General Electric MCC was installed around 1957. The circuit breakers were not modeled as a part of this study. When the existing equipment is replaced, an updated study will need to be performed.

**NO PROJECTS NEEDED, BOOSTER PUMP STATION SCHEDULED FOR DEMOLITION**
